Re: Foundation Review
1012 Betterton Circle
Dallas, TX

Certificate for Demolition & Removal

Project Name: Visual Foundation Evaluation Report

RE: Residence located at 1012 Betterton Cir., Dallas, TX 75203

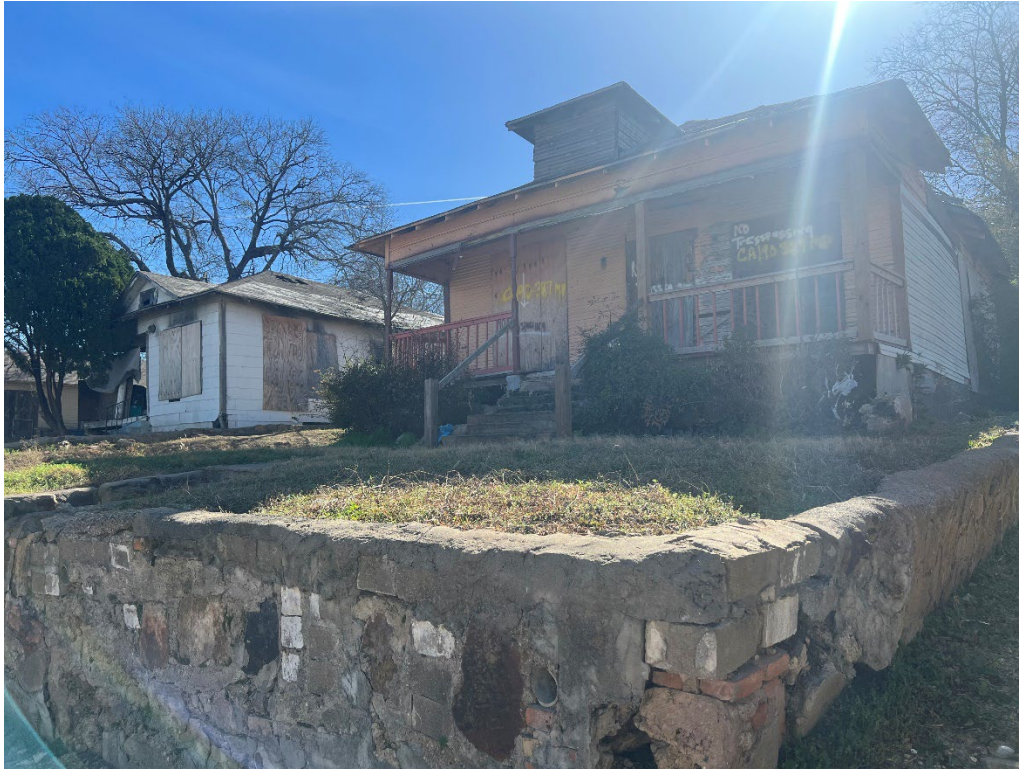
6686

The house is boarded up with no sign of anyone residing in it (see pic 6686). The overall shape and condition of the house is bad and signs of deterioration to the foundation and fascia system are evident.

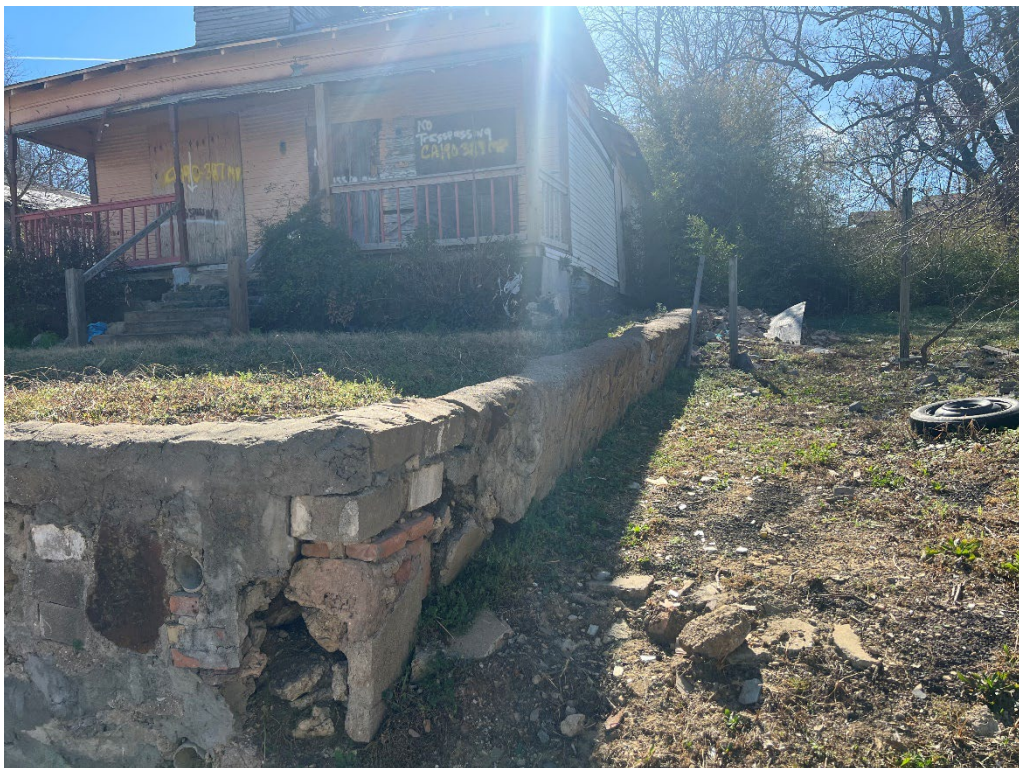
6687

The house siding is badly dated and damaged and missing a lot of backer supports that decrease the integrity of the entire structure (see pics 6702, 6703, 6704, and 6707). This damage has extended to the porch fascia as well (see pic 6687).

Finally, due to lack of maintenance and possible lack of proper drainage, the retaining wall north of the house is uneven and crumbling (see pic 6687).

1. A licensed professional should inspect the integrity of the entire structure and porch's floor joist, support beams and foundation.
2. Replace any detreated wood members with treated lumber, detreated pier columns shall be replaced with CMU (Cinder) blocks.
3. Laser level the entire house.
4. Replace missing siding and repair existing fascia.
5. Repair hazardous front porch including steps and concrete retaining wall.

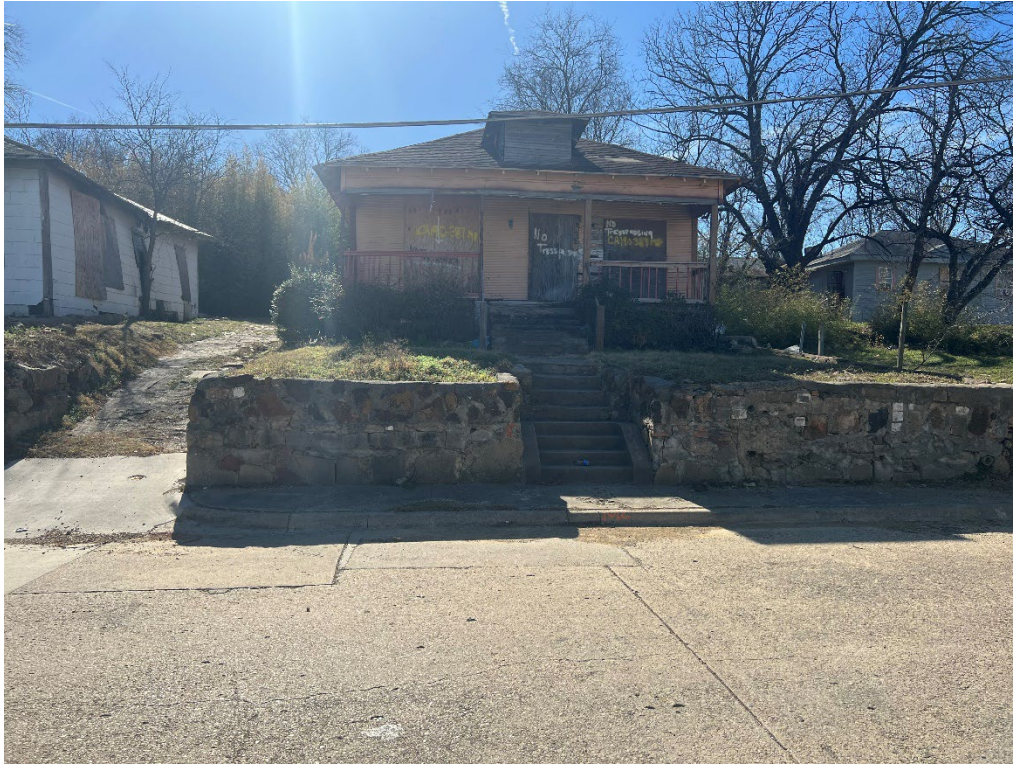
6688

The driveway is totally damaged past Right-of-Way (ROW) (see pics 6688, 6698, and 6699). The backyard is overgrown with reeds and is inaccessible.

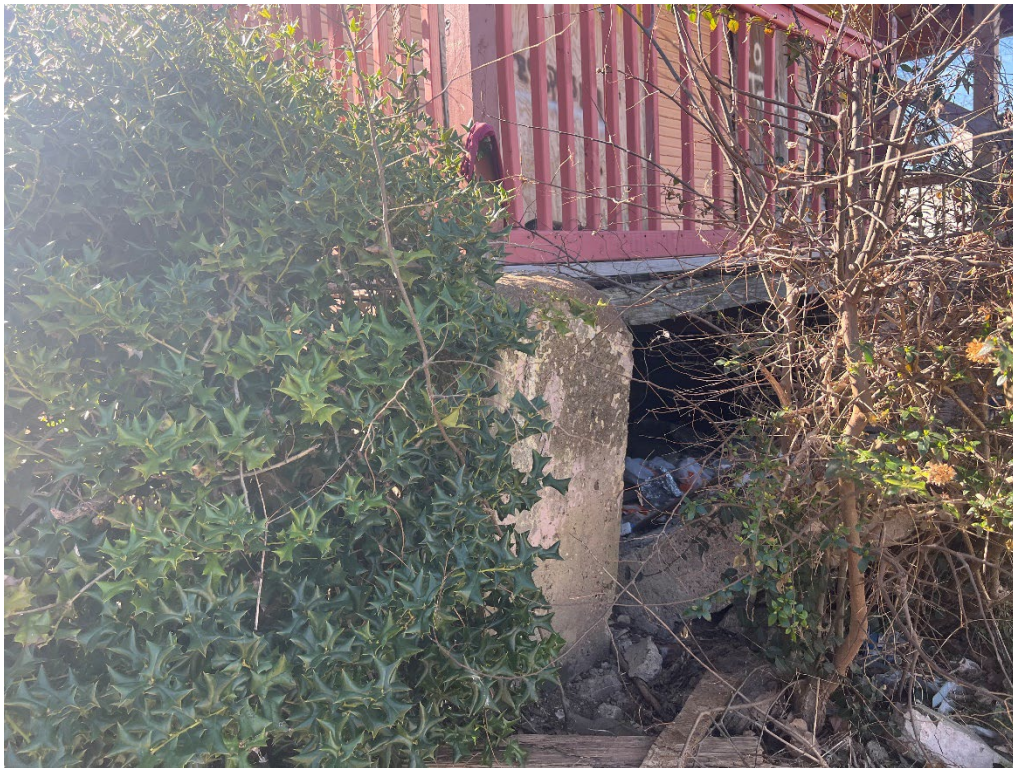
6689

The house support system requires immediate attention as several tree trunks have been used to fix the foundation (see pics 6689, 6690, 6695, 6696, and 6700). Also, the house is leaning, which is indicative of loss of leveling.

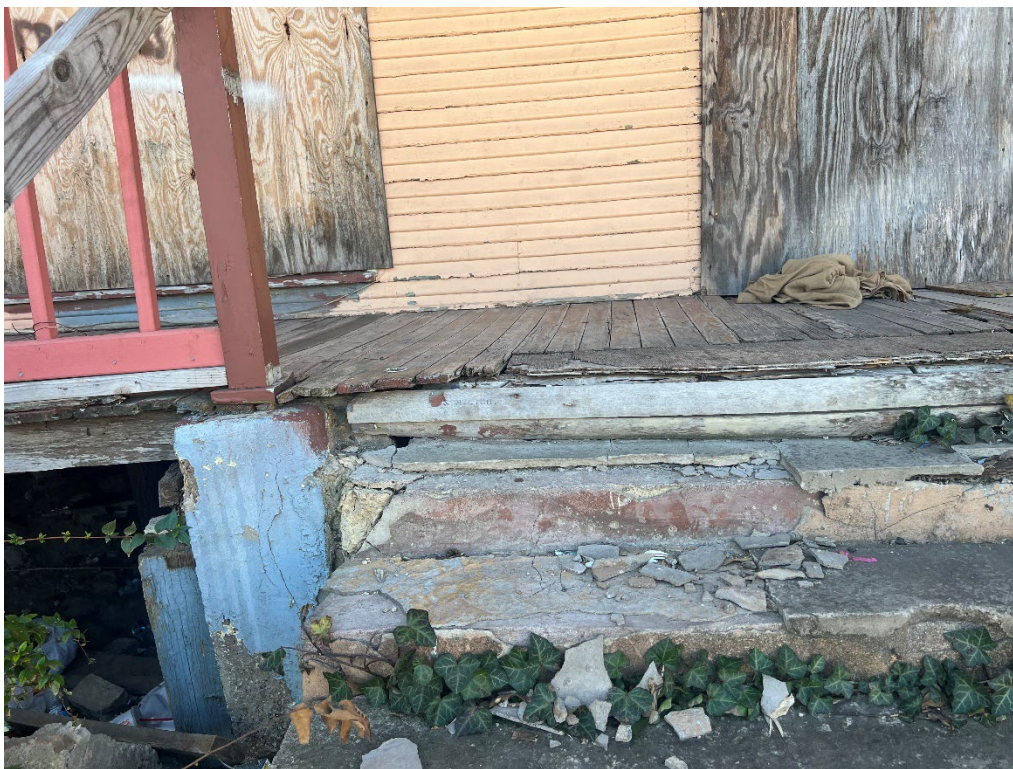
6691

The front porch concrete steps have failed and are hazardous (see pics 6691, 6692, and 6694). Further, the porch wood flooring is unstable and has broken in several areas.
