Re: Foundation Review
1012 Betterton Circle
Dallas, TX

Certificate for Demolition & Removal

Project Name: Visual Foundation Evaluation Report

RE: Residence located at 1012 Betterton Cir., Dallas, TX 75203

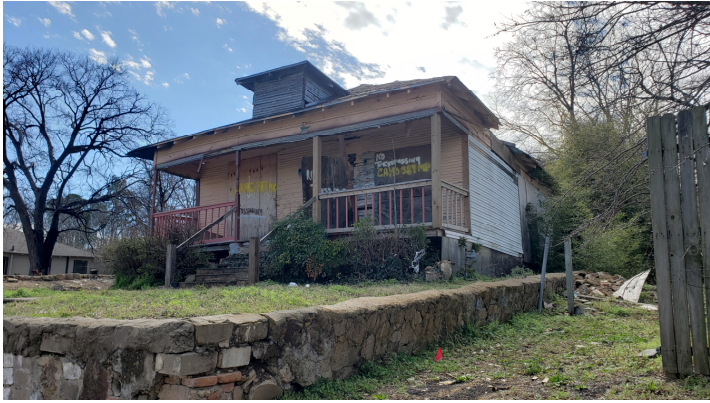
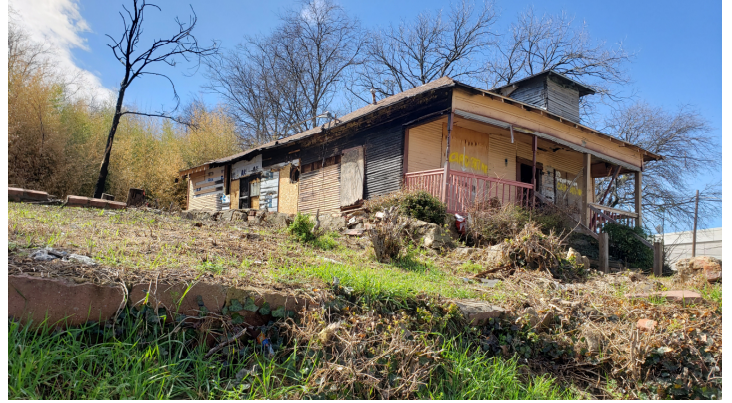
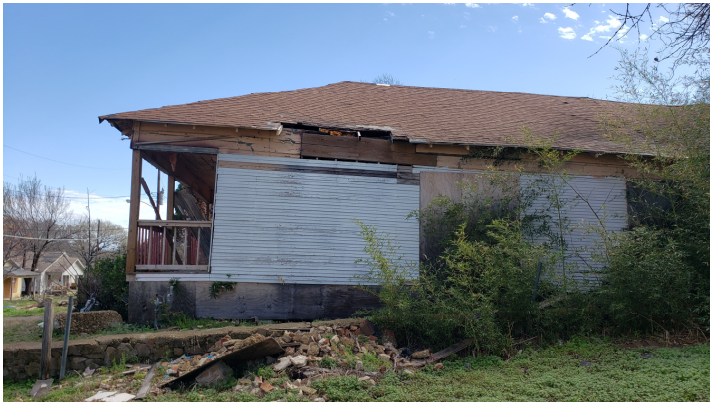
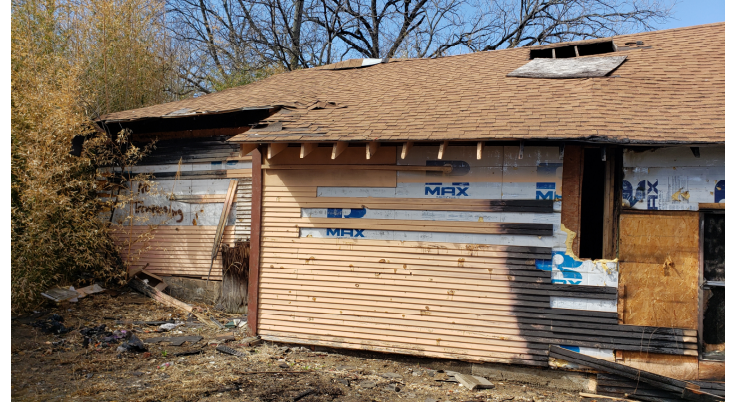
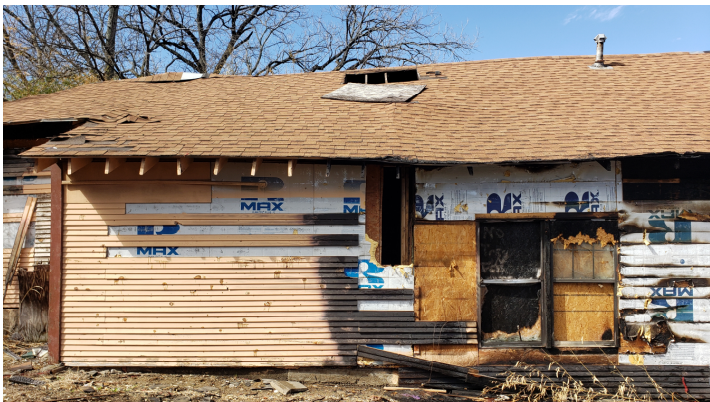
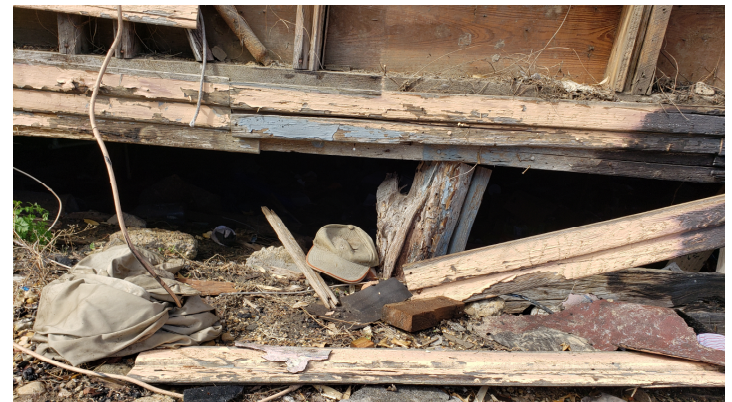
- The existing structure is currently supported by tree stumps at the foundation, which are now leaning.
- The foundation's stringers are located in large spans, causing structural inadequacies

- The roof joists are not properly rested on the top plate, due to an inward load and lack of bridging between the structural members, causing the roof joists to rotate.
- The roof is caving due to buckling of the walls and an inadequate floor system.

- The exterior walls on the east elevation due to inadequate foundation support.
- A fire has occurred at the east side of the residence, adding direct damage to that entire side, and causing indirect smoke damage throughout the residence.
- The studs at the walls are randomly spaced.
- The wall are leaning inwardly on the east side of the residence.

- Unevenness of the floor is caused by inadequate foundation support.
- The floor joist, and beams are not properly sized.

- The steps will need to be completely replace due to deterioration of the concrete.

- The retaining wall located at front of residence will need to be repaired or replaced due to the deterioration of its structural integrity.

During our site visit on February 22, 2023, we have found that the residence, in its current condition, is inefficient in terms of structural stability. As your consultant, we advise that the residence be demolished for new construction to prevent the structure from collapsing and causing harm to any persons providing construction services on the property. Below you will see our findings:
