The site for the Victory Block D Garage improvements is located west of the W Hotel with primary frontages on Victory Park Lane and Victory Avenue. The site currently exists as a single use garage with three levels of structured parking, two of which are above grade.

Victory Block D Garage

VICTORY PARK

BLOCK D RETAIL & GARAGE IMPROVEMENTS

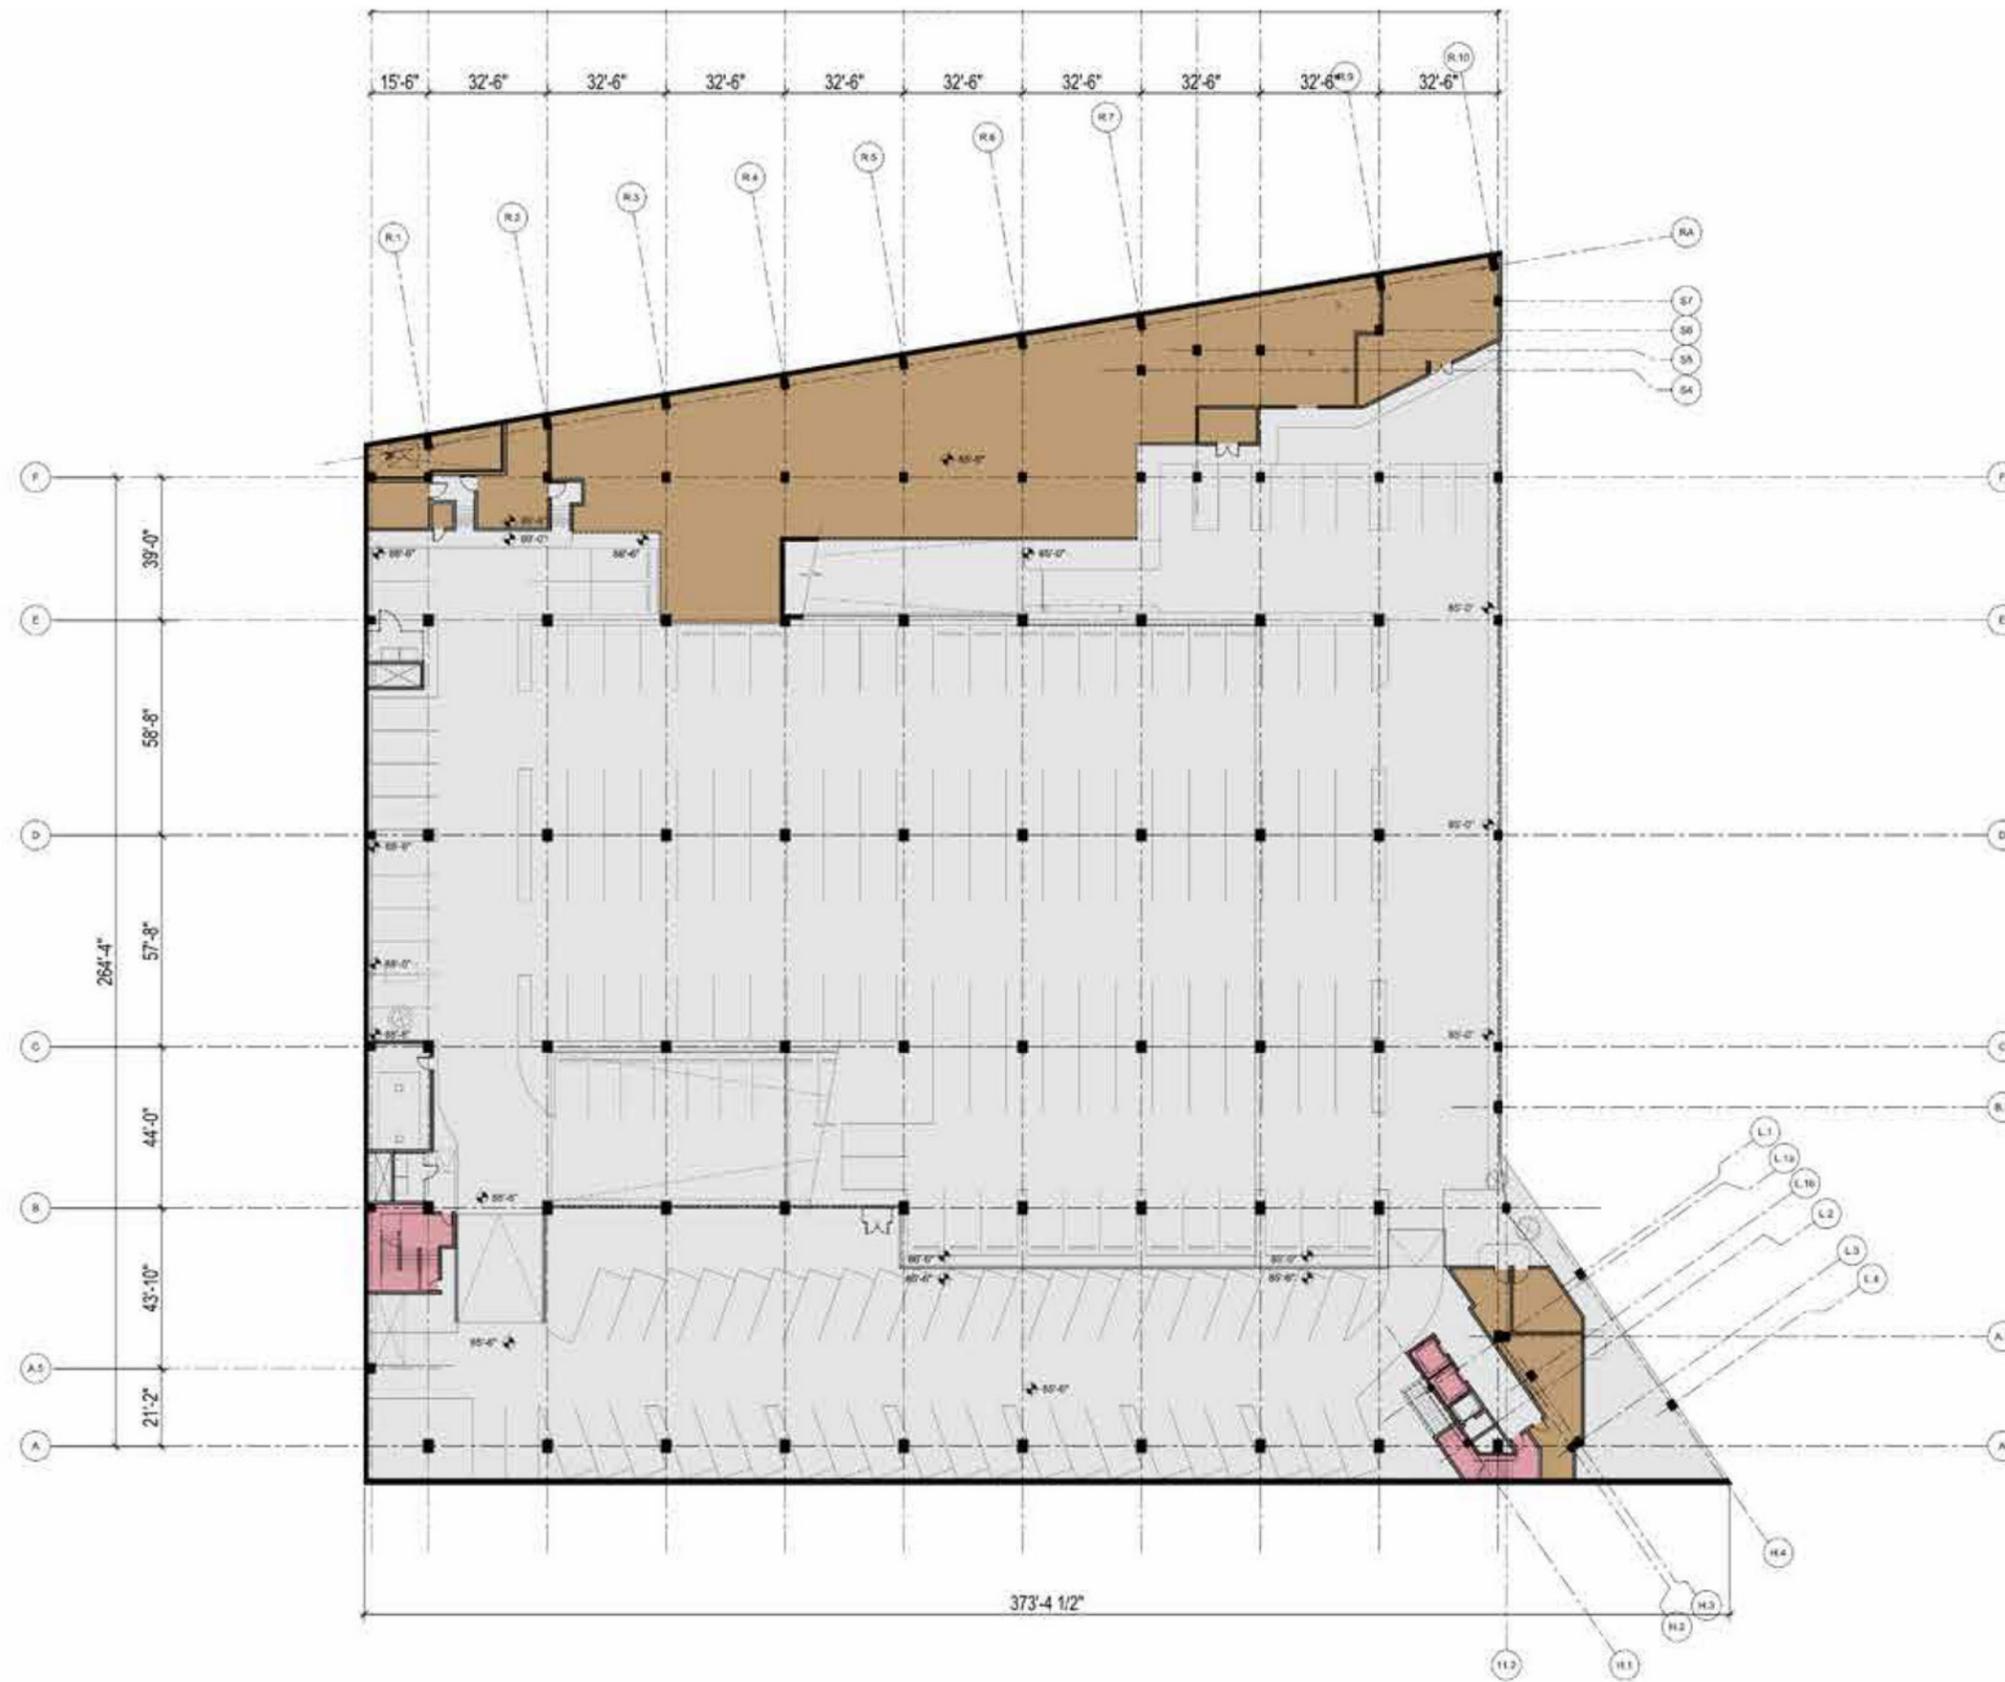
- COMMON CIRCULATION
- SERVICE
- RESTAURANTS
- RETAIL
- PARKING

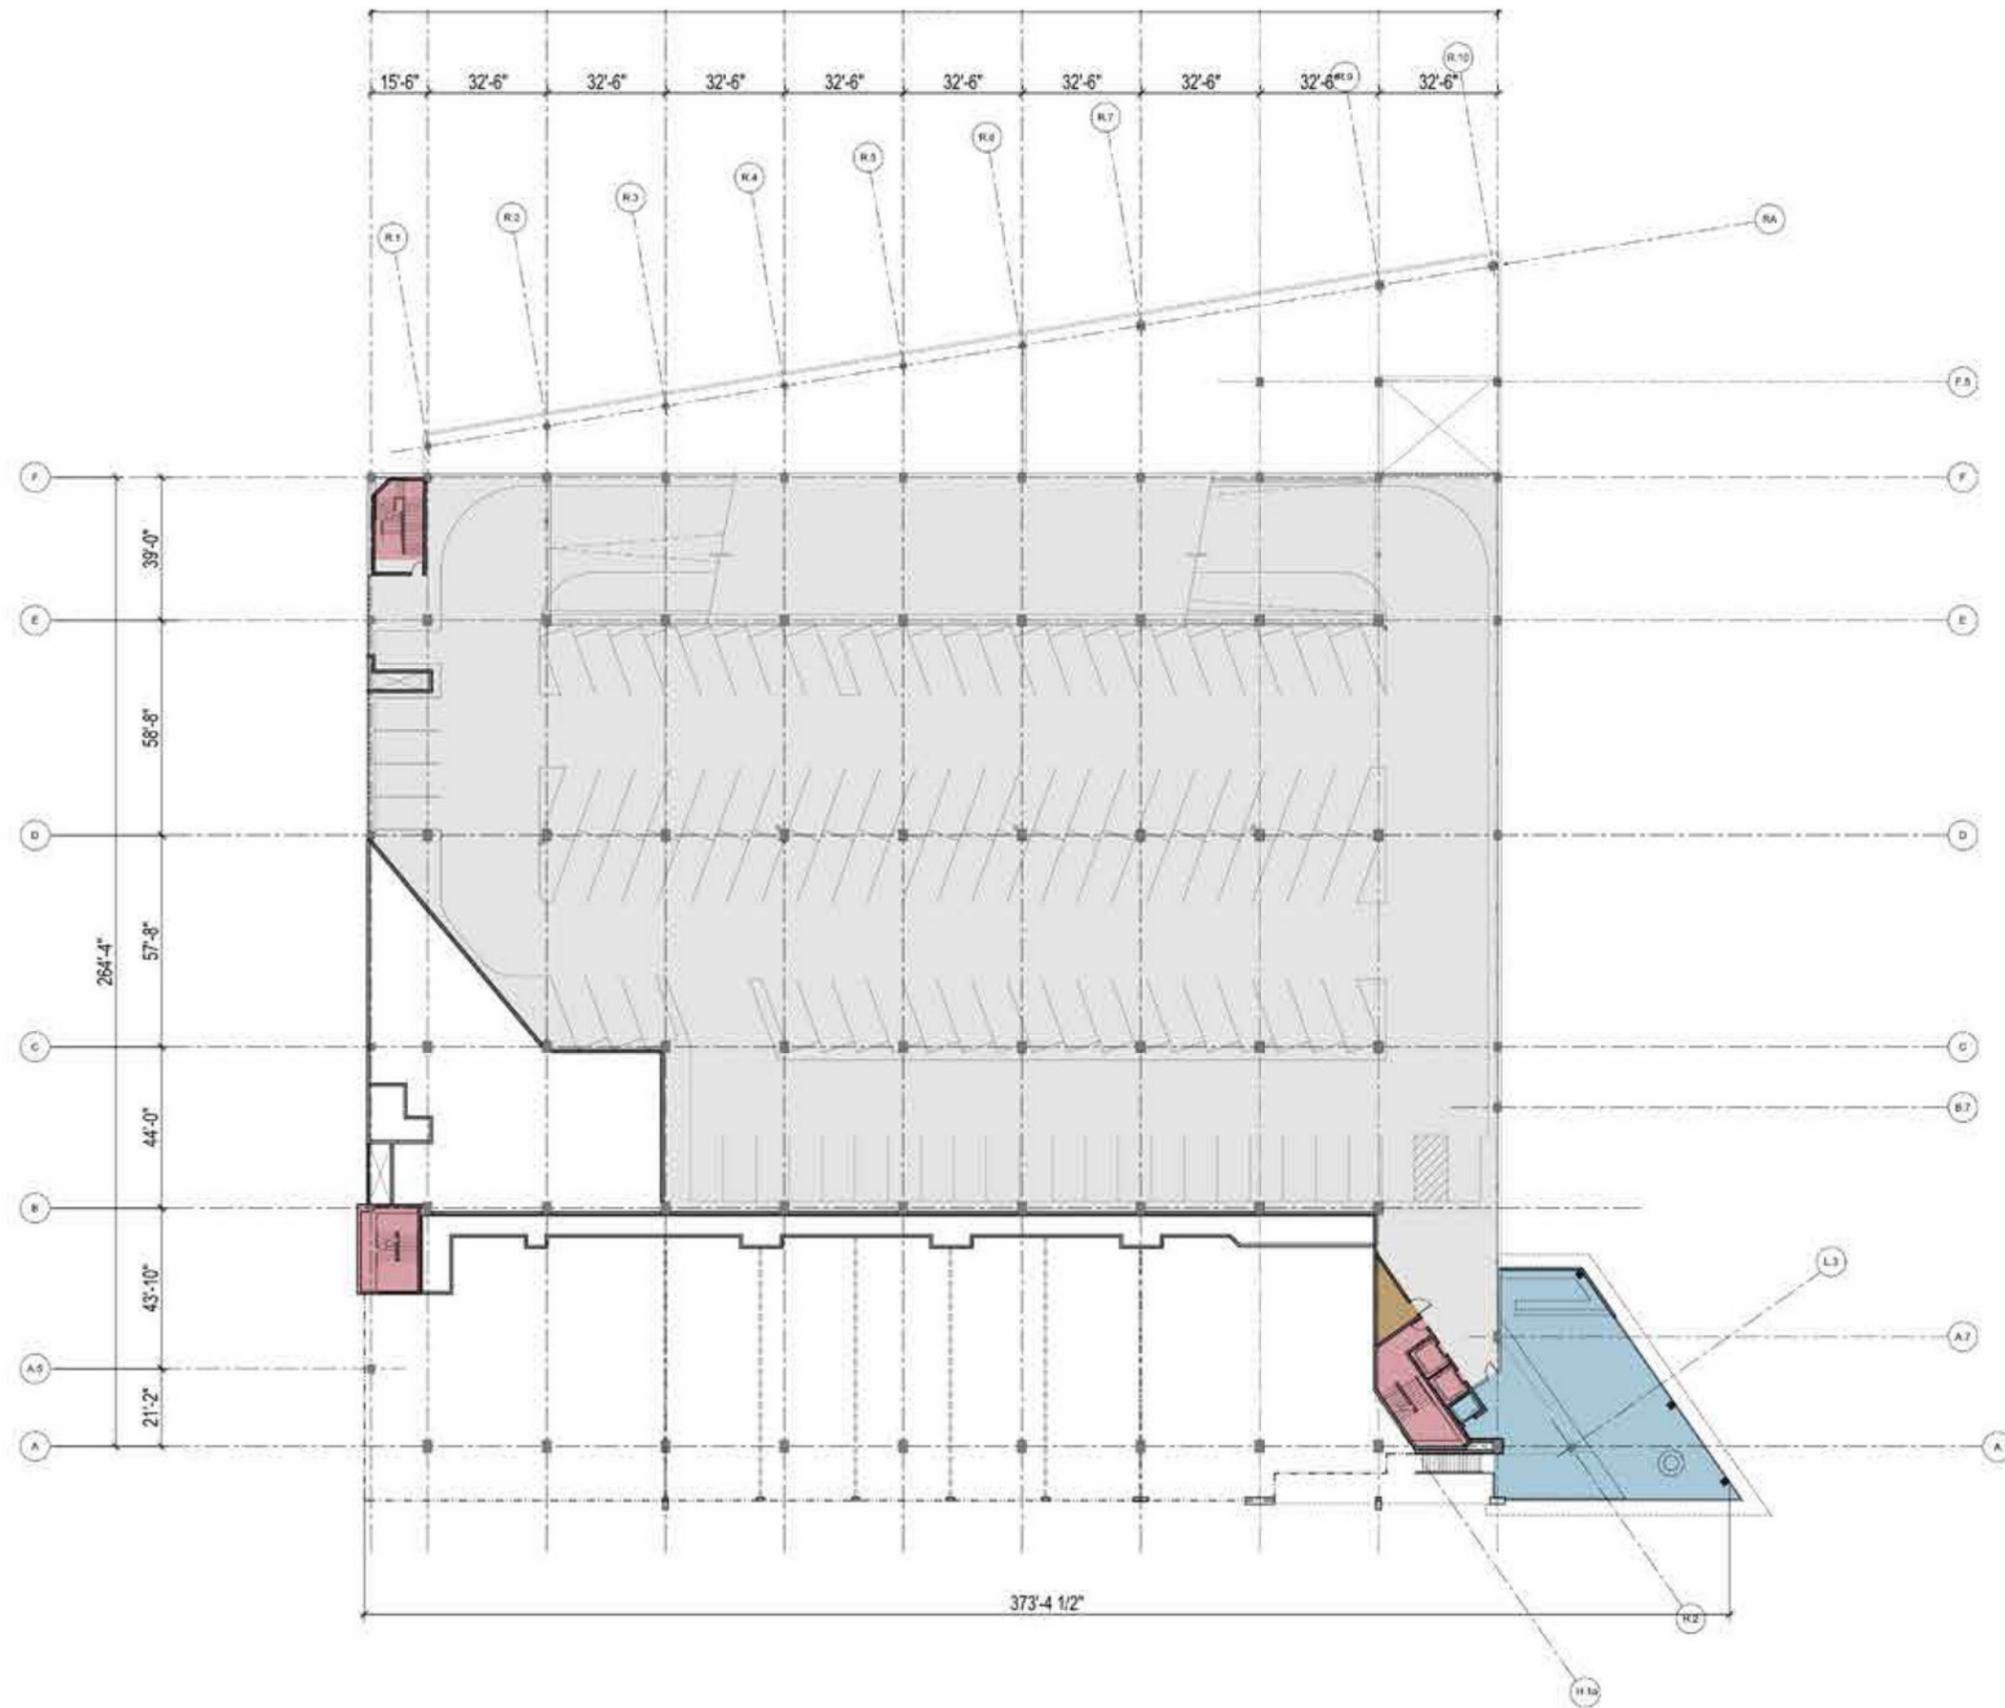
- COMMON CIRCULATION
- SERVICE
- RESTAURANTS
- RETAIL
- PARKING

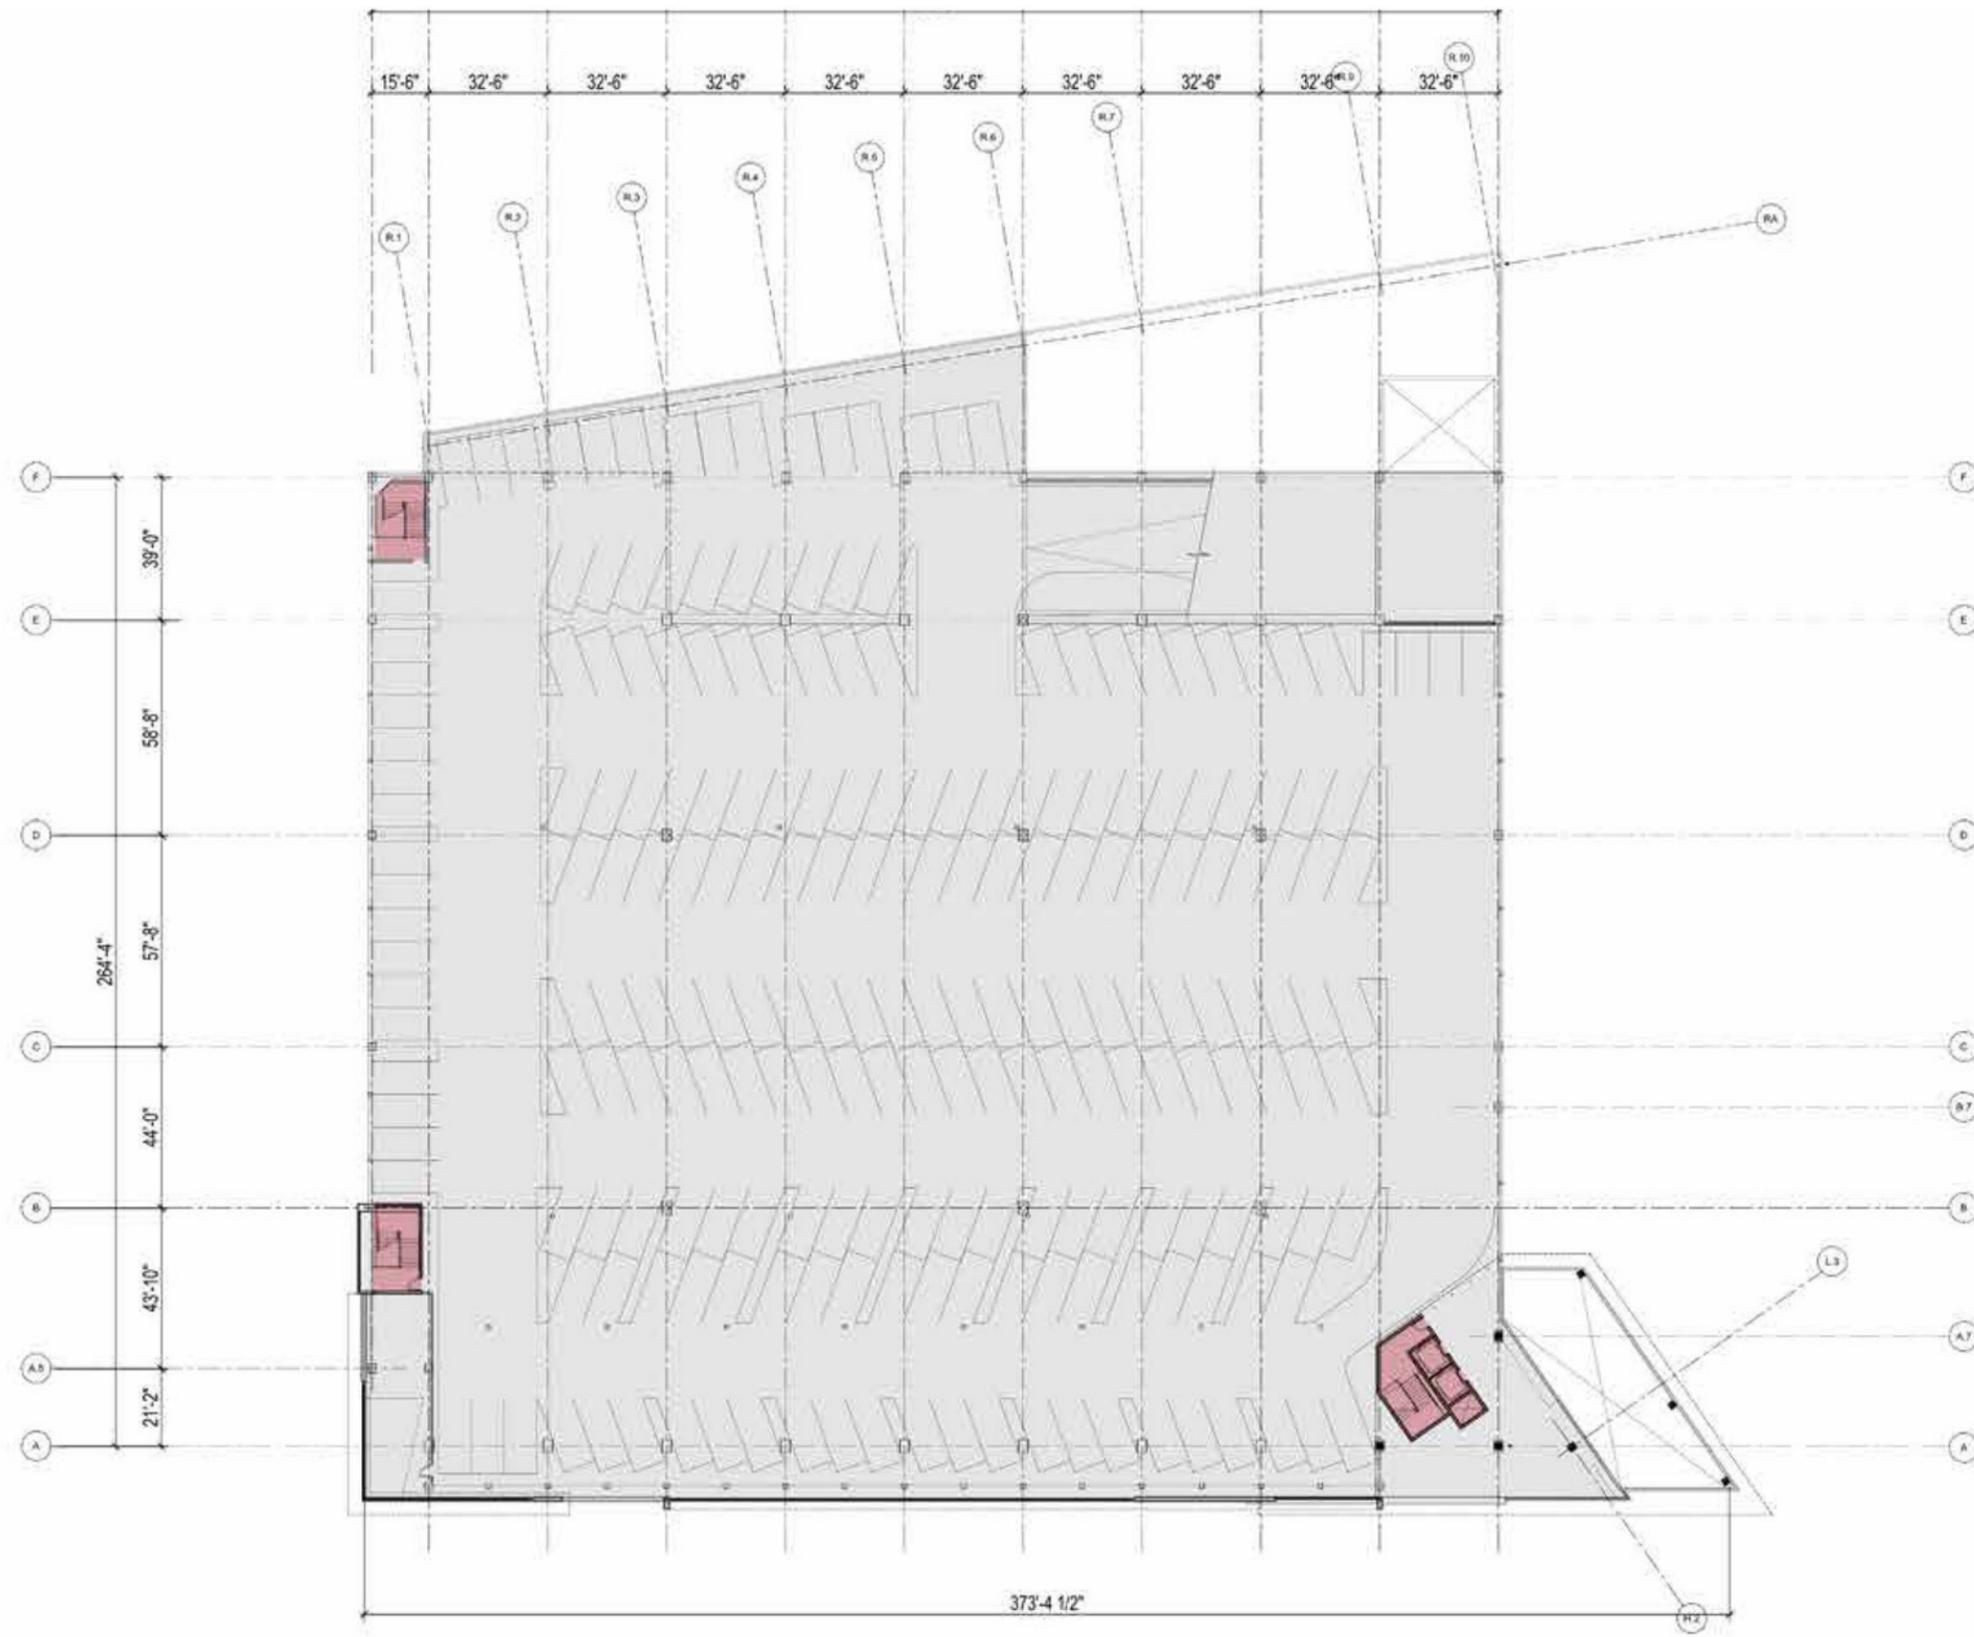
- COMMON CIRCULATION
- SERVICE
- RESTAURANTS
- RETAIL
- PARKING

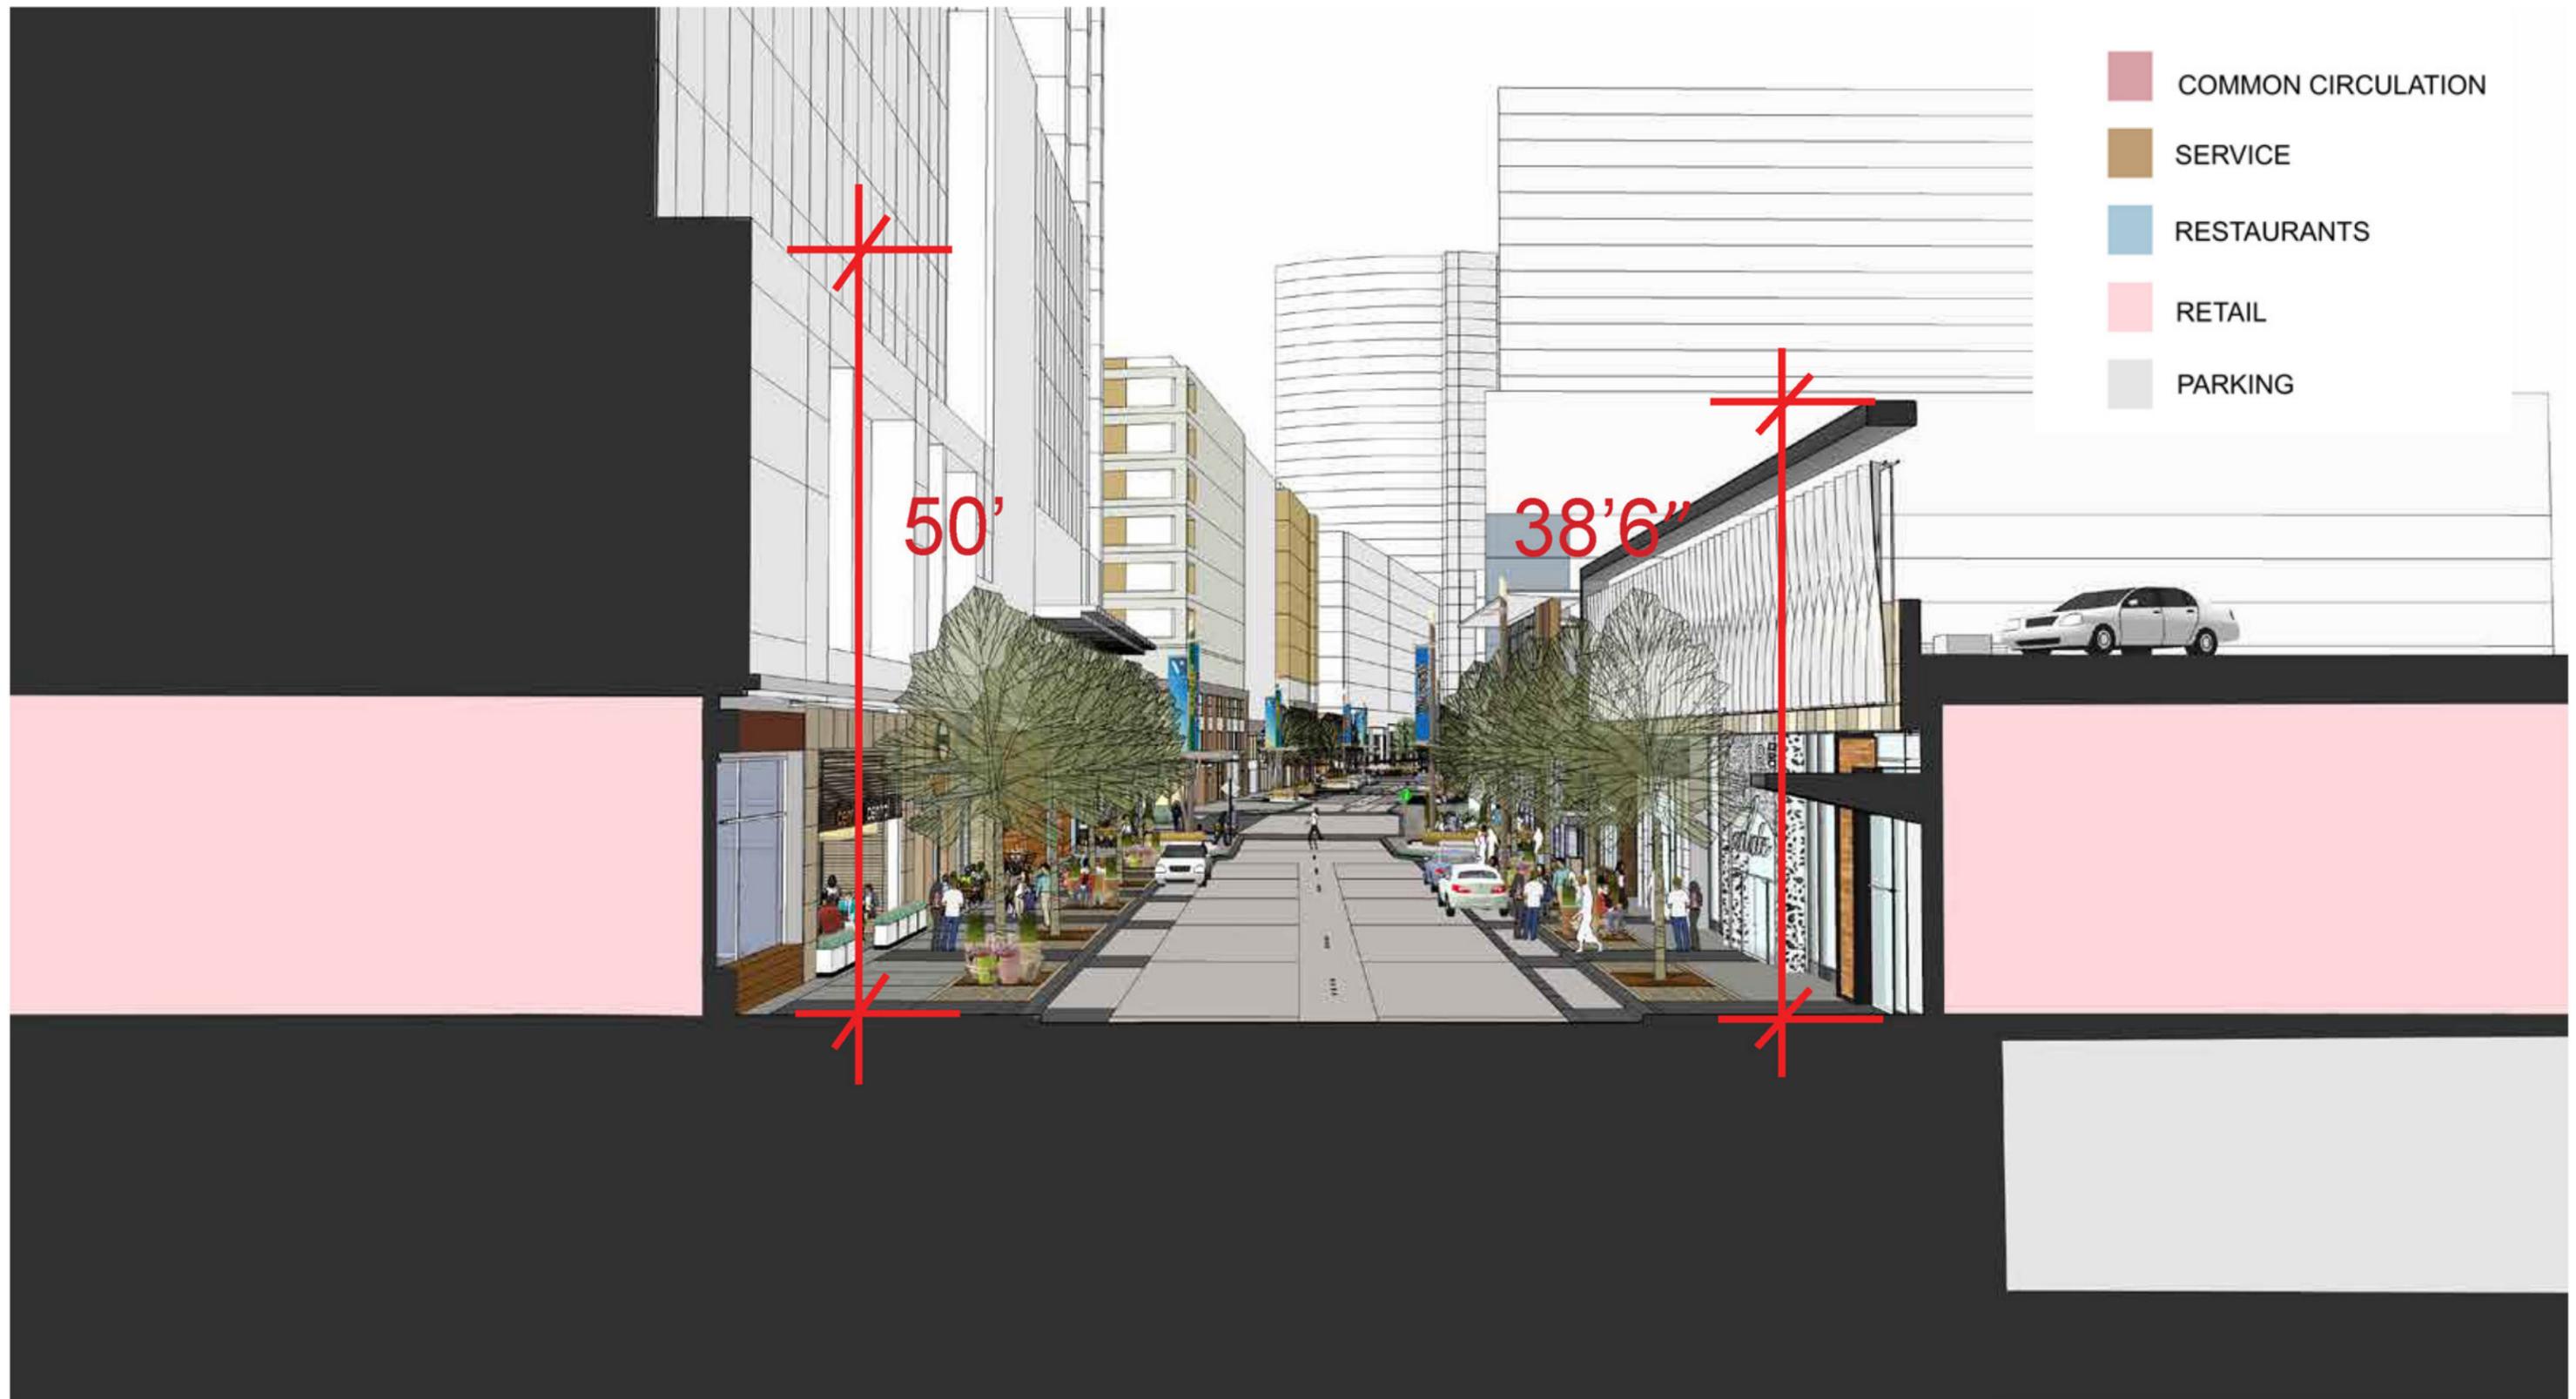
- COMMON CIRCULATION
- SERVICE
- RESTAURANTS
- RETAIL
- PARKING

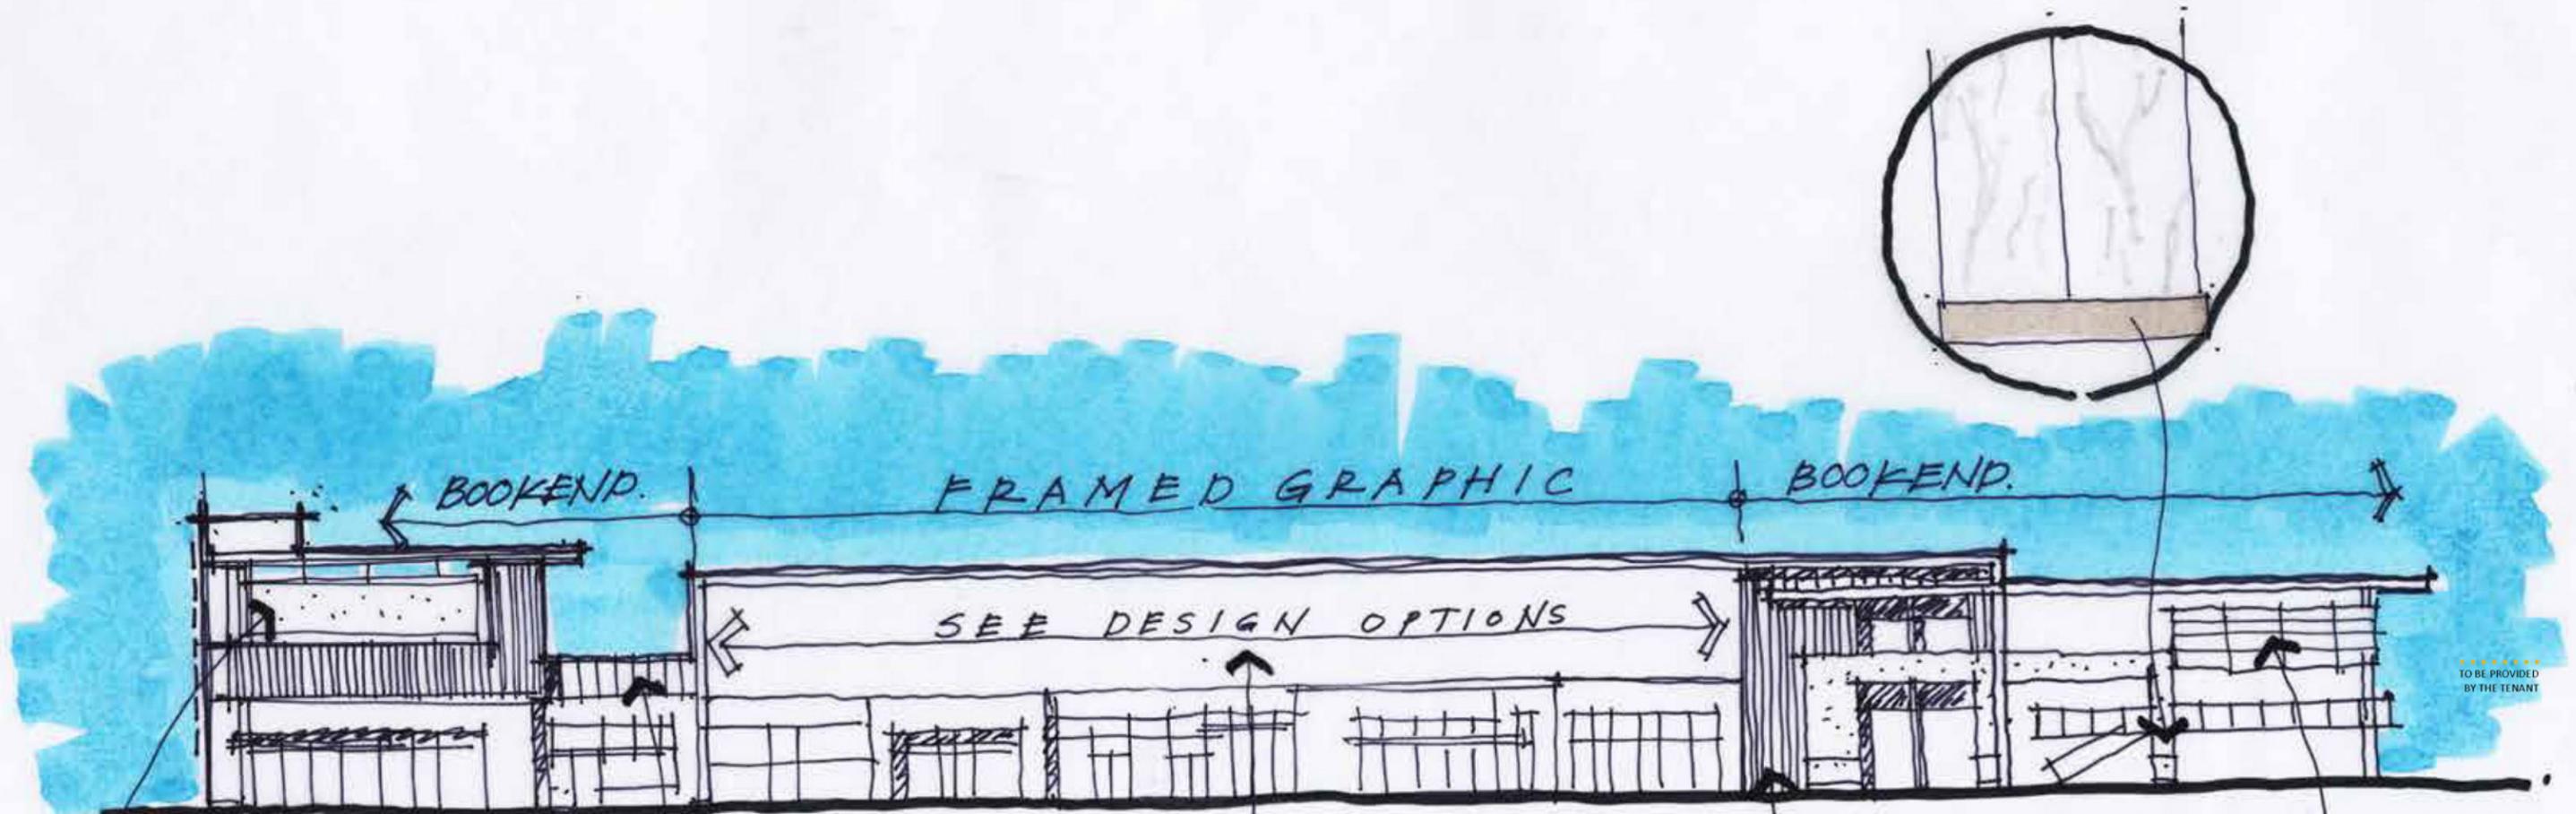
ELEVATION
N.T.S.

TO BE PROVIDED
BY THE TENANT

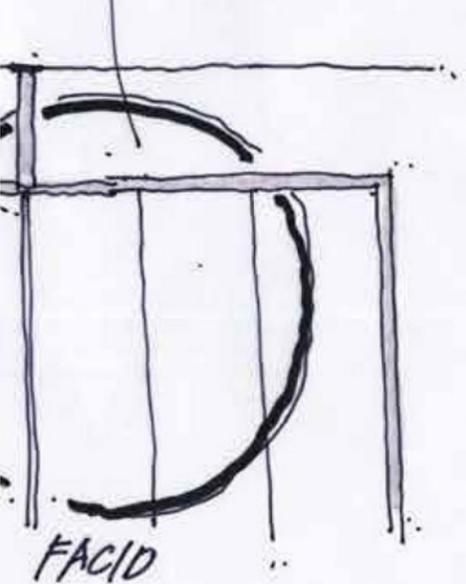
FACID

Facid structural system with Ferrari Fabric. 24% coverage of East Elevation.

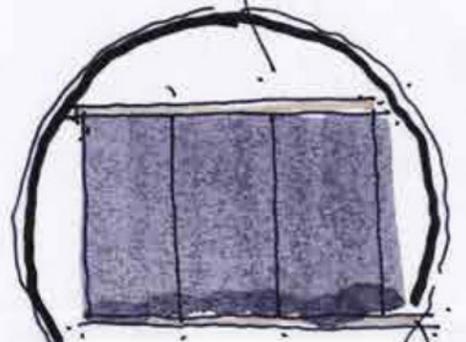
Stucco with high
quality finish.

Stucco with high quality finish. 7% coverage of North Elevation. T-207 Pebble Beach, AN-204 White Sand, OC-223 French Roast

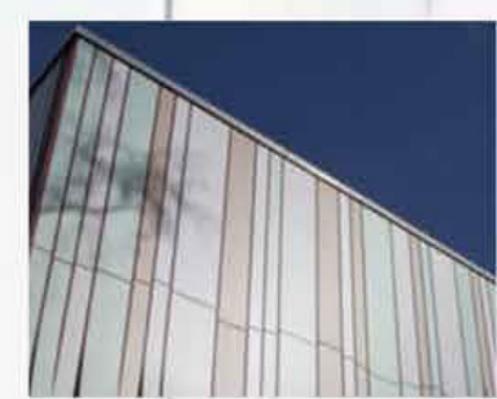
trespa with alternating widths
wood appearance

Trespa with wood-like finish. 20% coverage of East Elevation

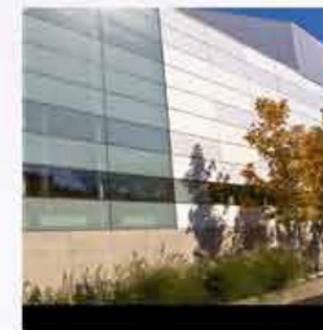
trespa panel

Trespa. 10% coverage of East Elevation.

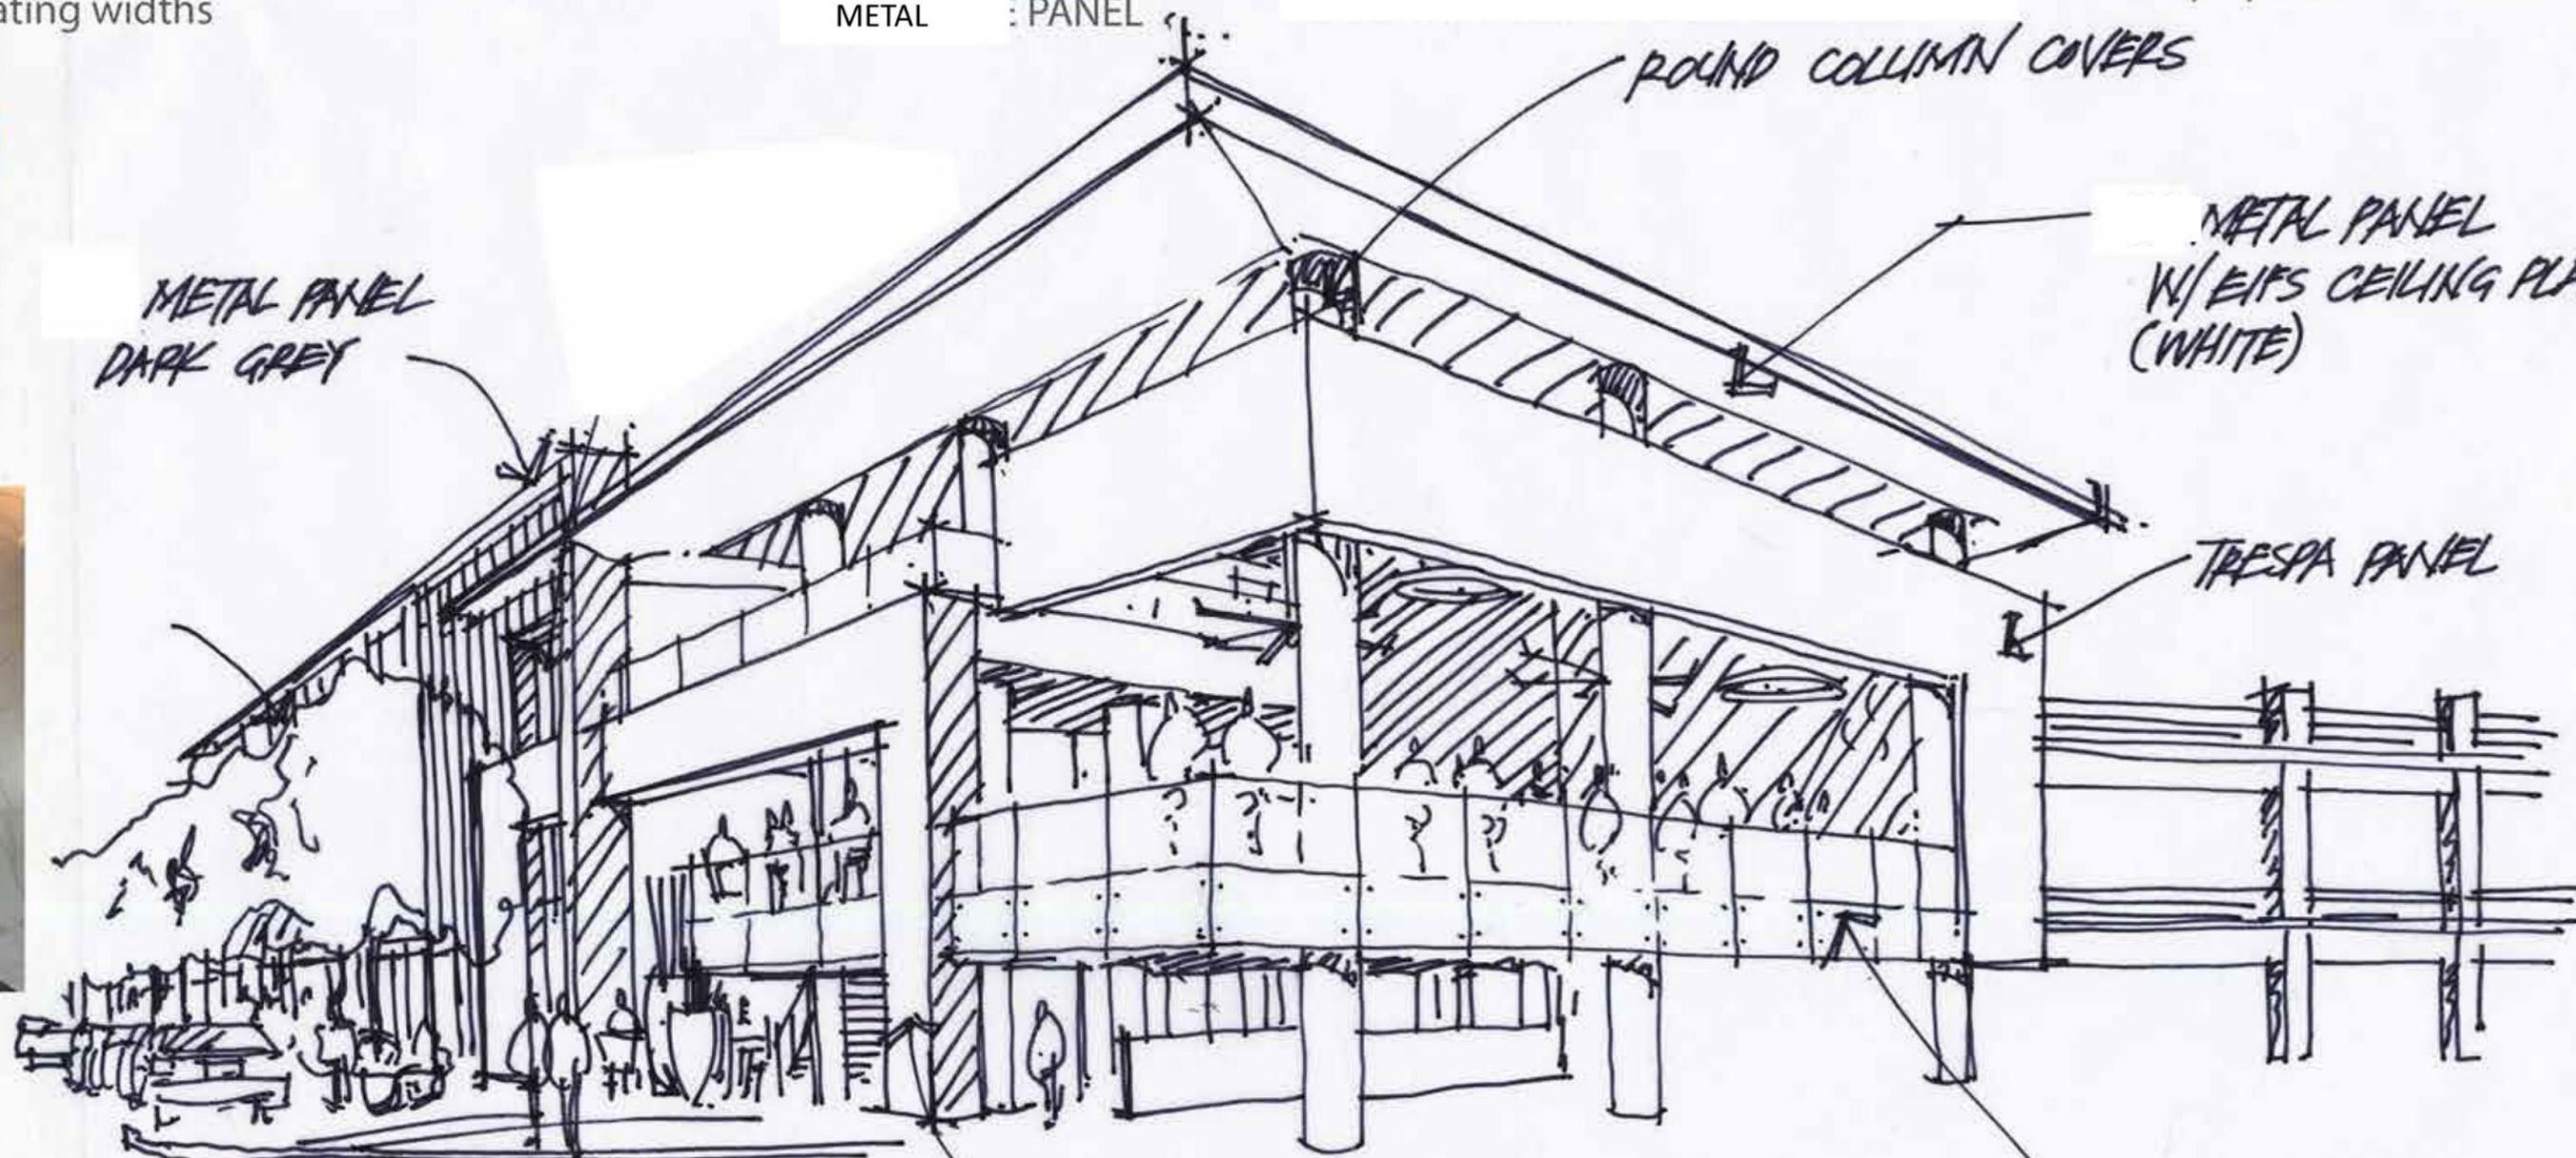
METAL PANEL
DARK GREY

METAL PANEL
W/ EPS CEILING PLANK
(WHITE)

TRESPA PANEL

ROUND COLUMN COVERS

WHITE MAN MADE STONE (PORCELAIN)
W/ BRUSHED STAINLESS STEEL BASE.

POINT SUPPORTED
GLASS RAILING.

Point supported guard rail. 10% coverage of East Elevation.

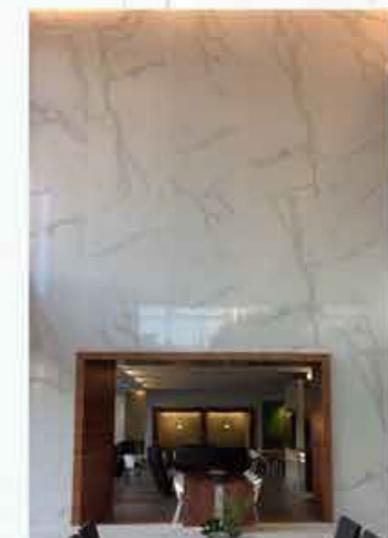
large format porcelain tile

Large format porcelain tile. 11% coverage of East Elevation.
