The site for the Victory Block D Garage improvements is located west of the W Hotel with primary frontages on Victory Park Lane and Victory Avenue. The site currently exists as a single use garage with three levels of structured parking, two of which are above grade.

Victory Block D Garage

VICTORY PARK

BLOCK D RETAIL & GARAGE IMPROVEMENTS

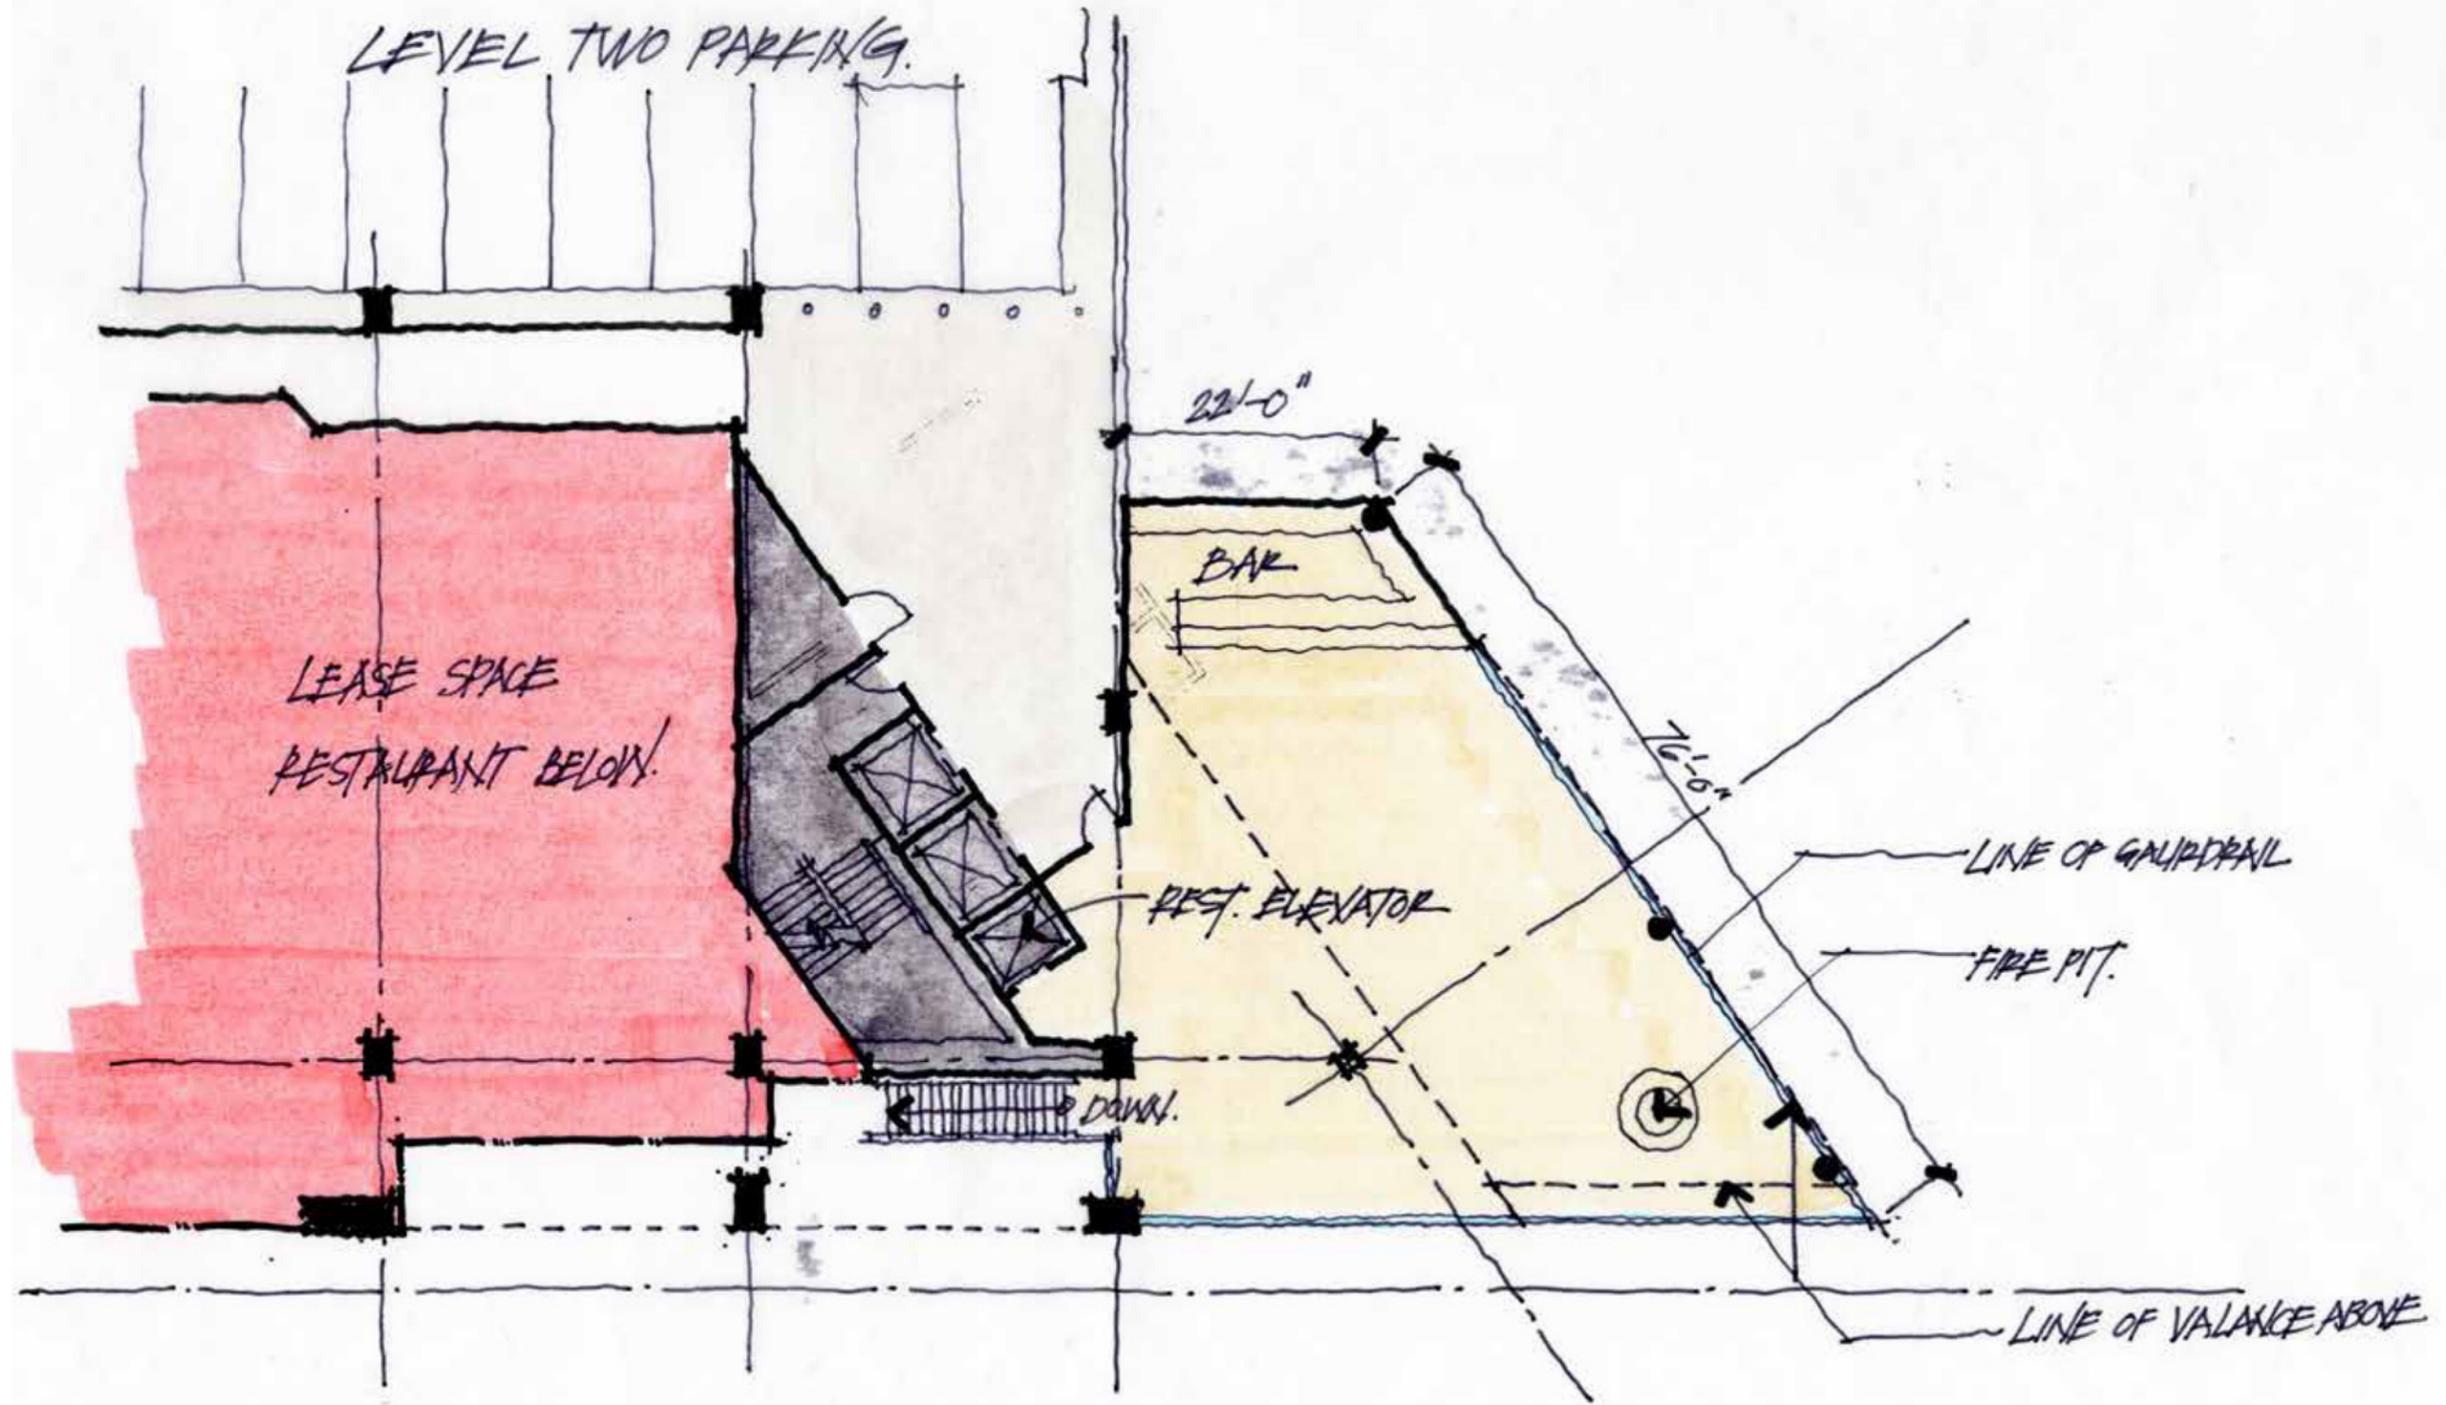
LEVEL TWO
 1/16" = 1'-0" VICTORY-BUCK D
 RTKL 10.27.2014

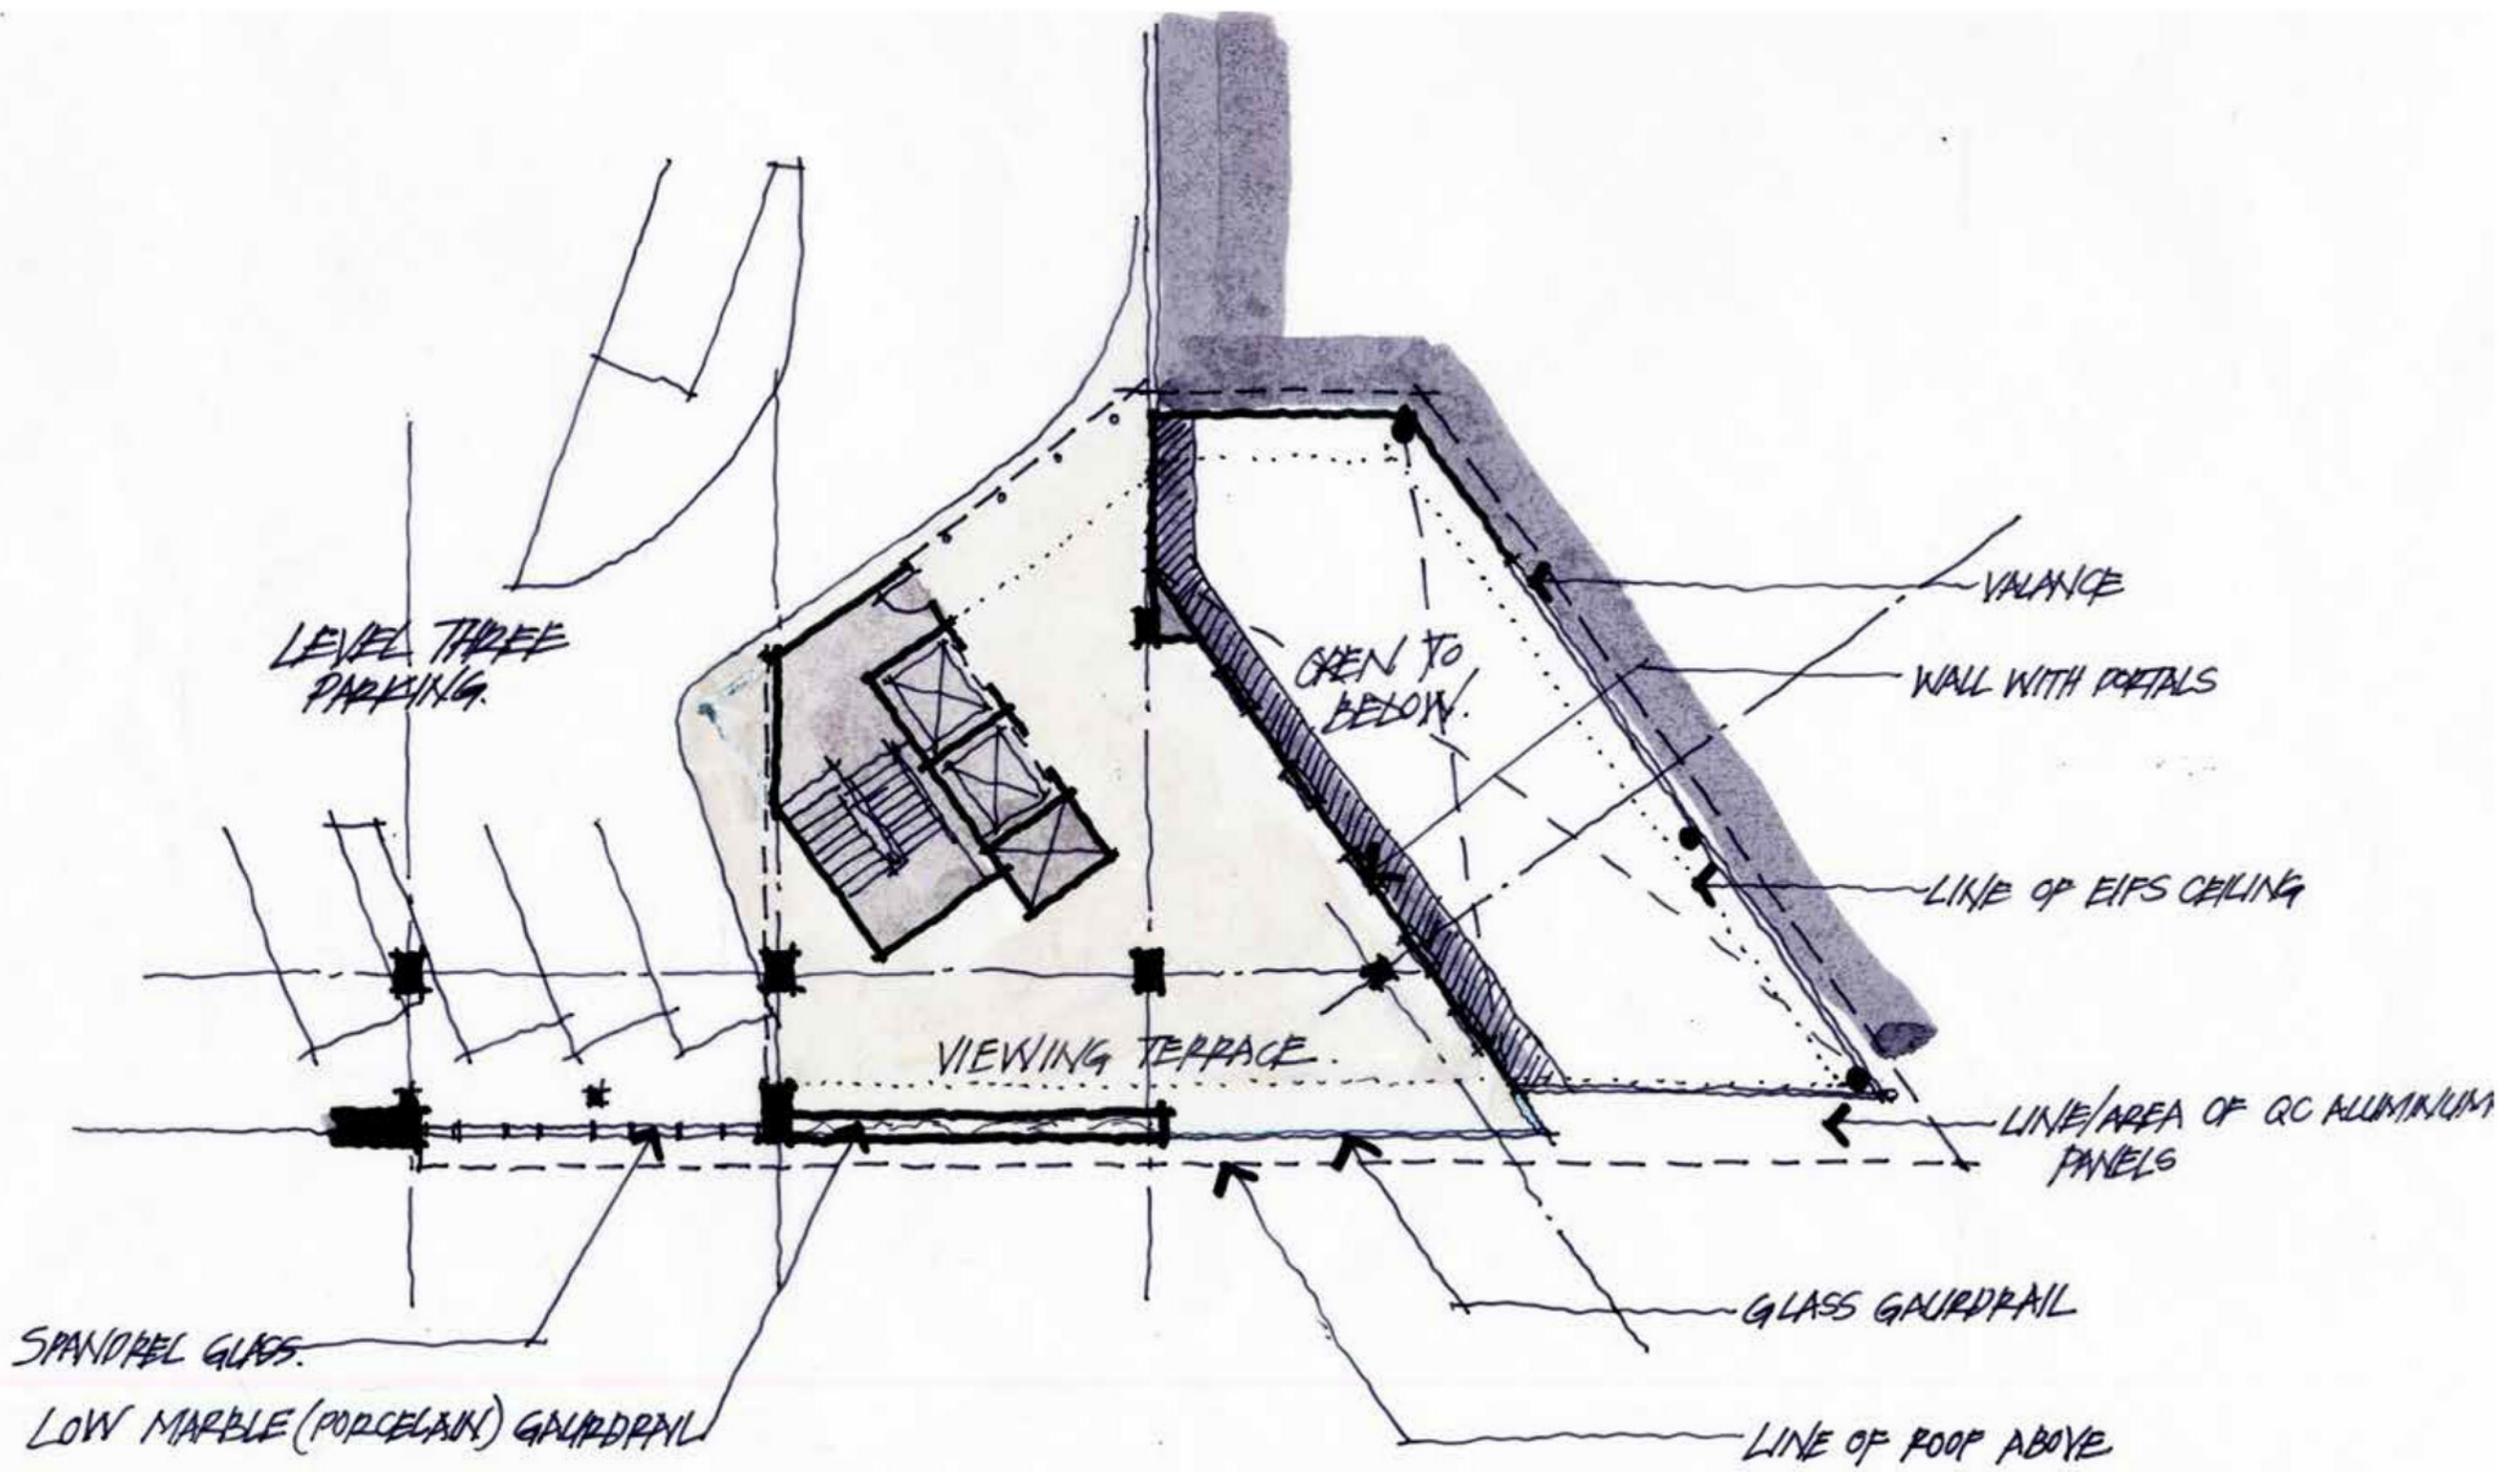
LEVEL THREE
 1/16" = 1'-0" VICTORY BLOCK D RTKL
 10.27.2014

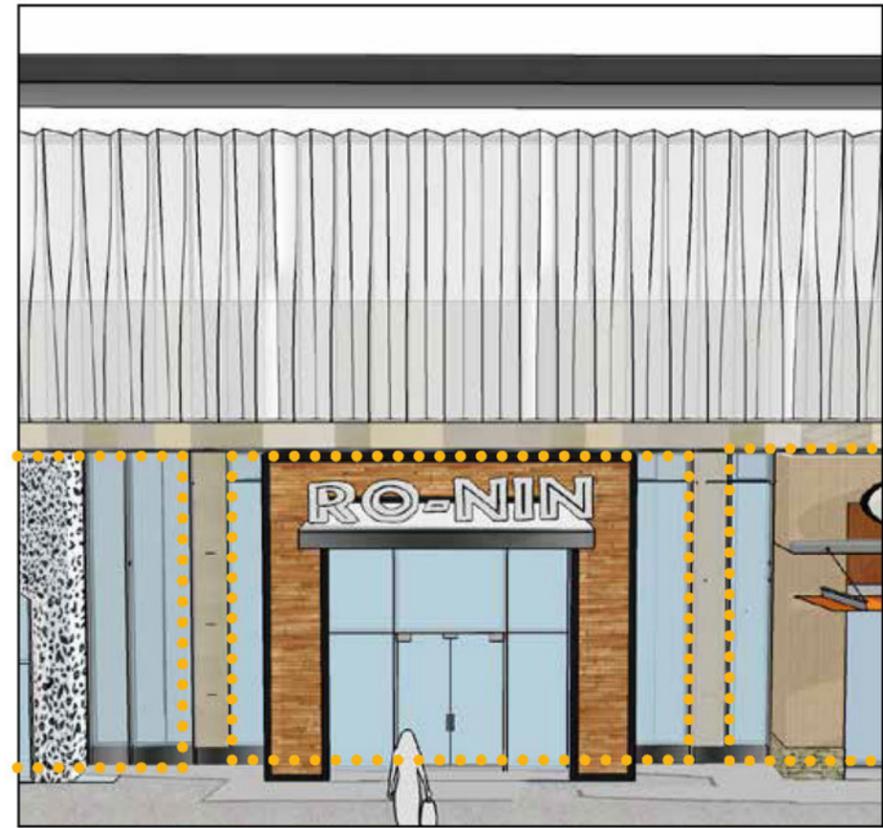
Enlarged Elevation

Note: ●●●●● Storefront designs by individual tenants. Designs to comply with Victory Park Tenant Design Criteria.

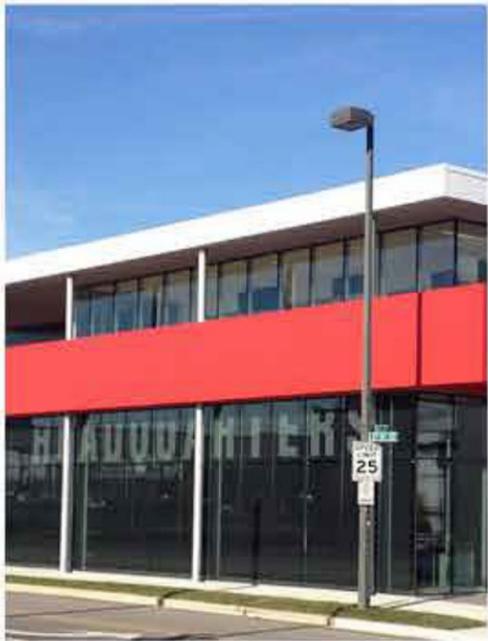
QC FACADE PANEL

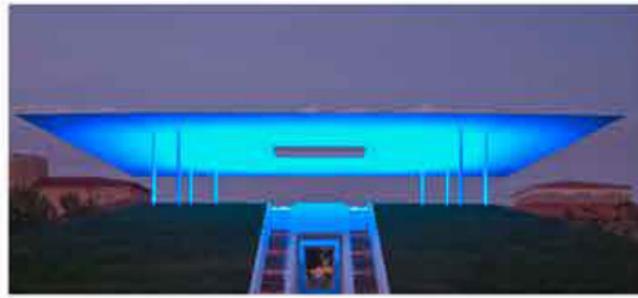
uplighting onto soffit

EYEBROW
METAL PANEL
(WHITE)

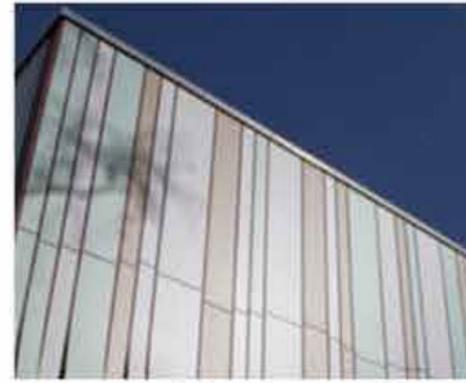
trespa with alternating widths
wood appearance

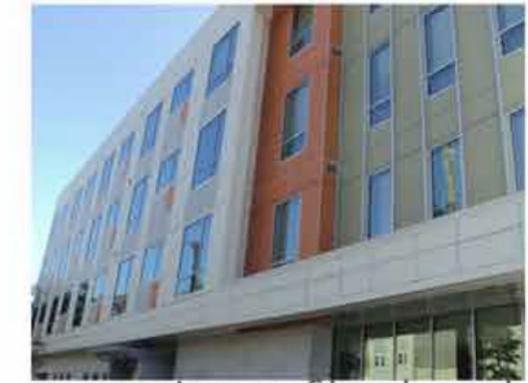
cementitious fiber board

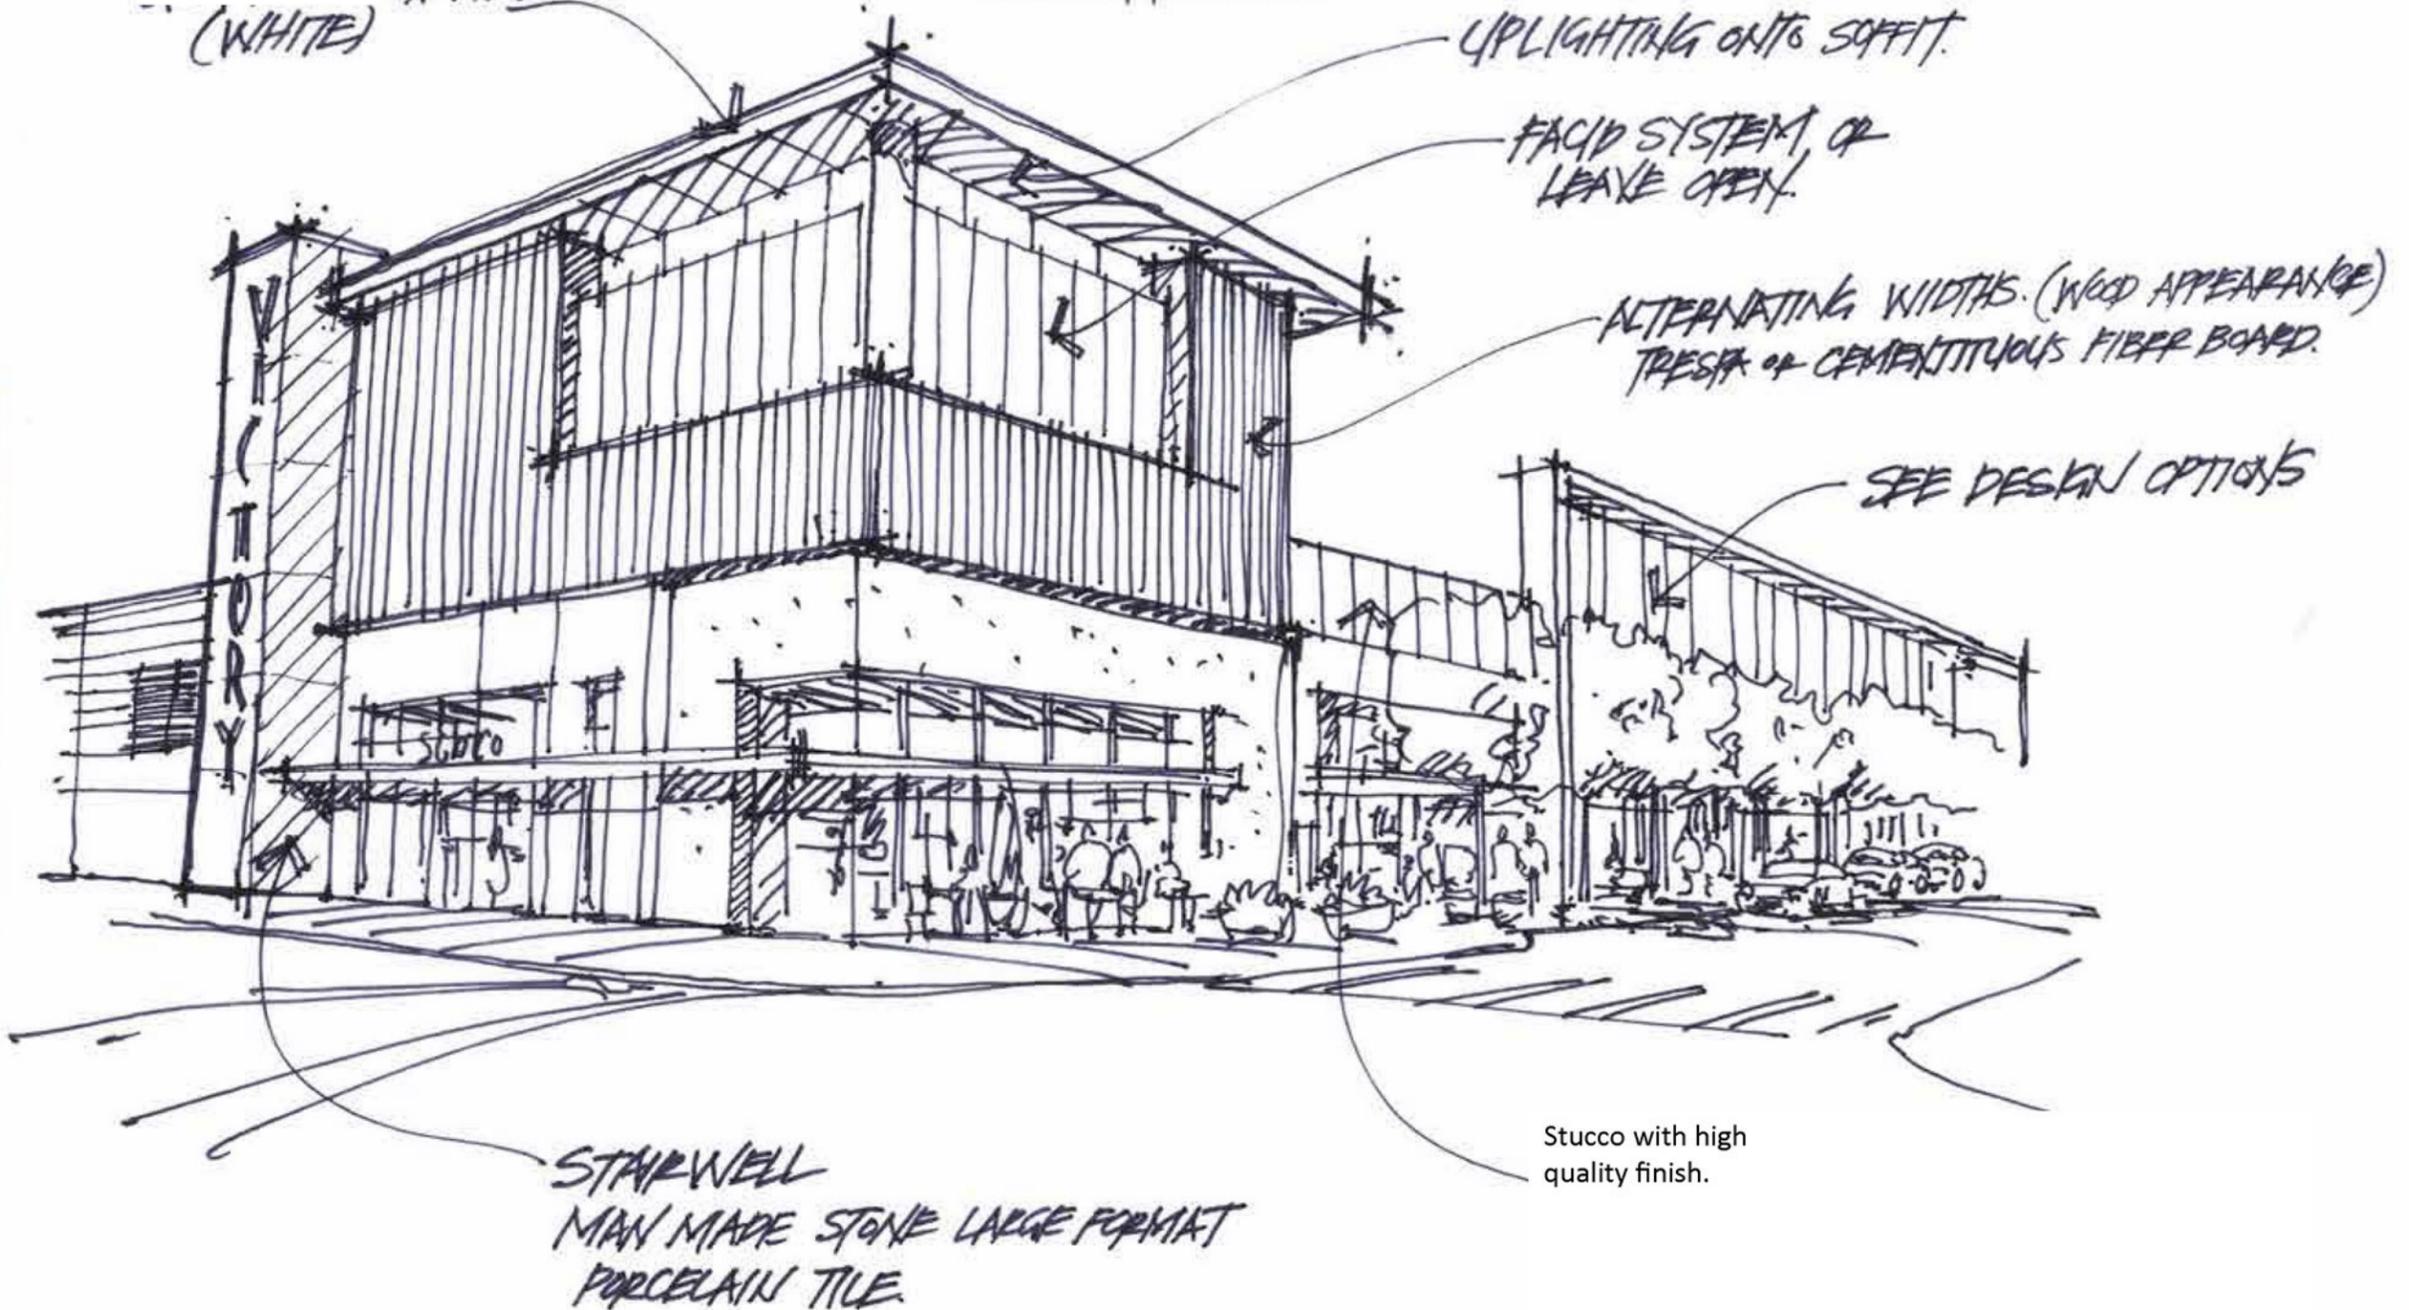
UPLIGHTING ONTO SOFFIT.

*FACID SYSTEM, OR
LEAVE OPEN.*

*ALTERNATING WIDTHS. (WOOD APPEARANCE)
TRESPA OR CEMENTITIOUS FIBER BOARD.*

SEE DESIGN OPTIONS

Stucco with high
quality finish.

*STARWELL
MAN MADE STONE LARGE FORMAT
PORCELAIN TILE.*

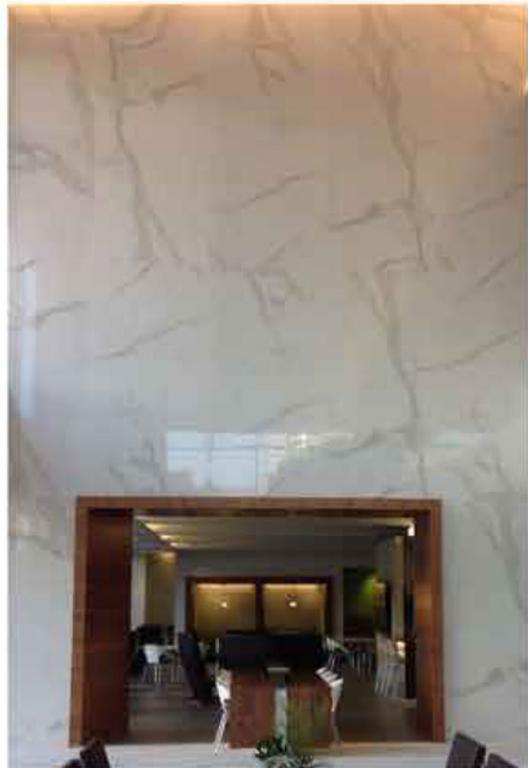
large format porcelain tile

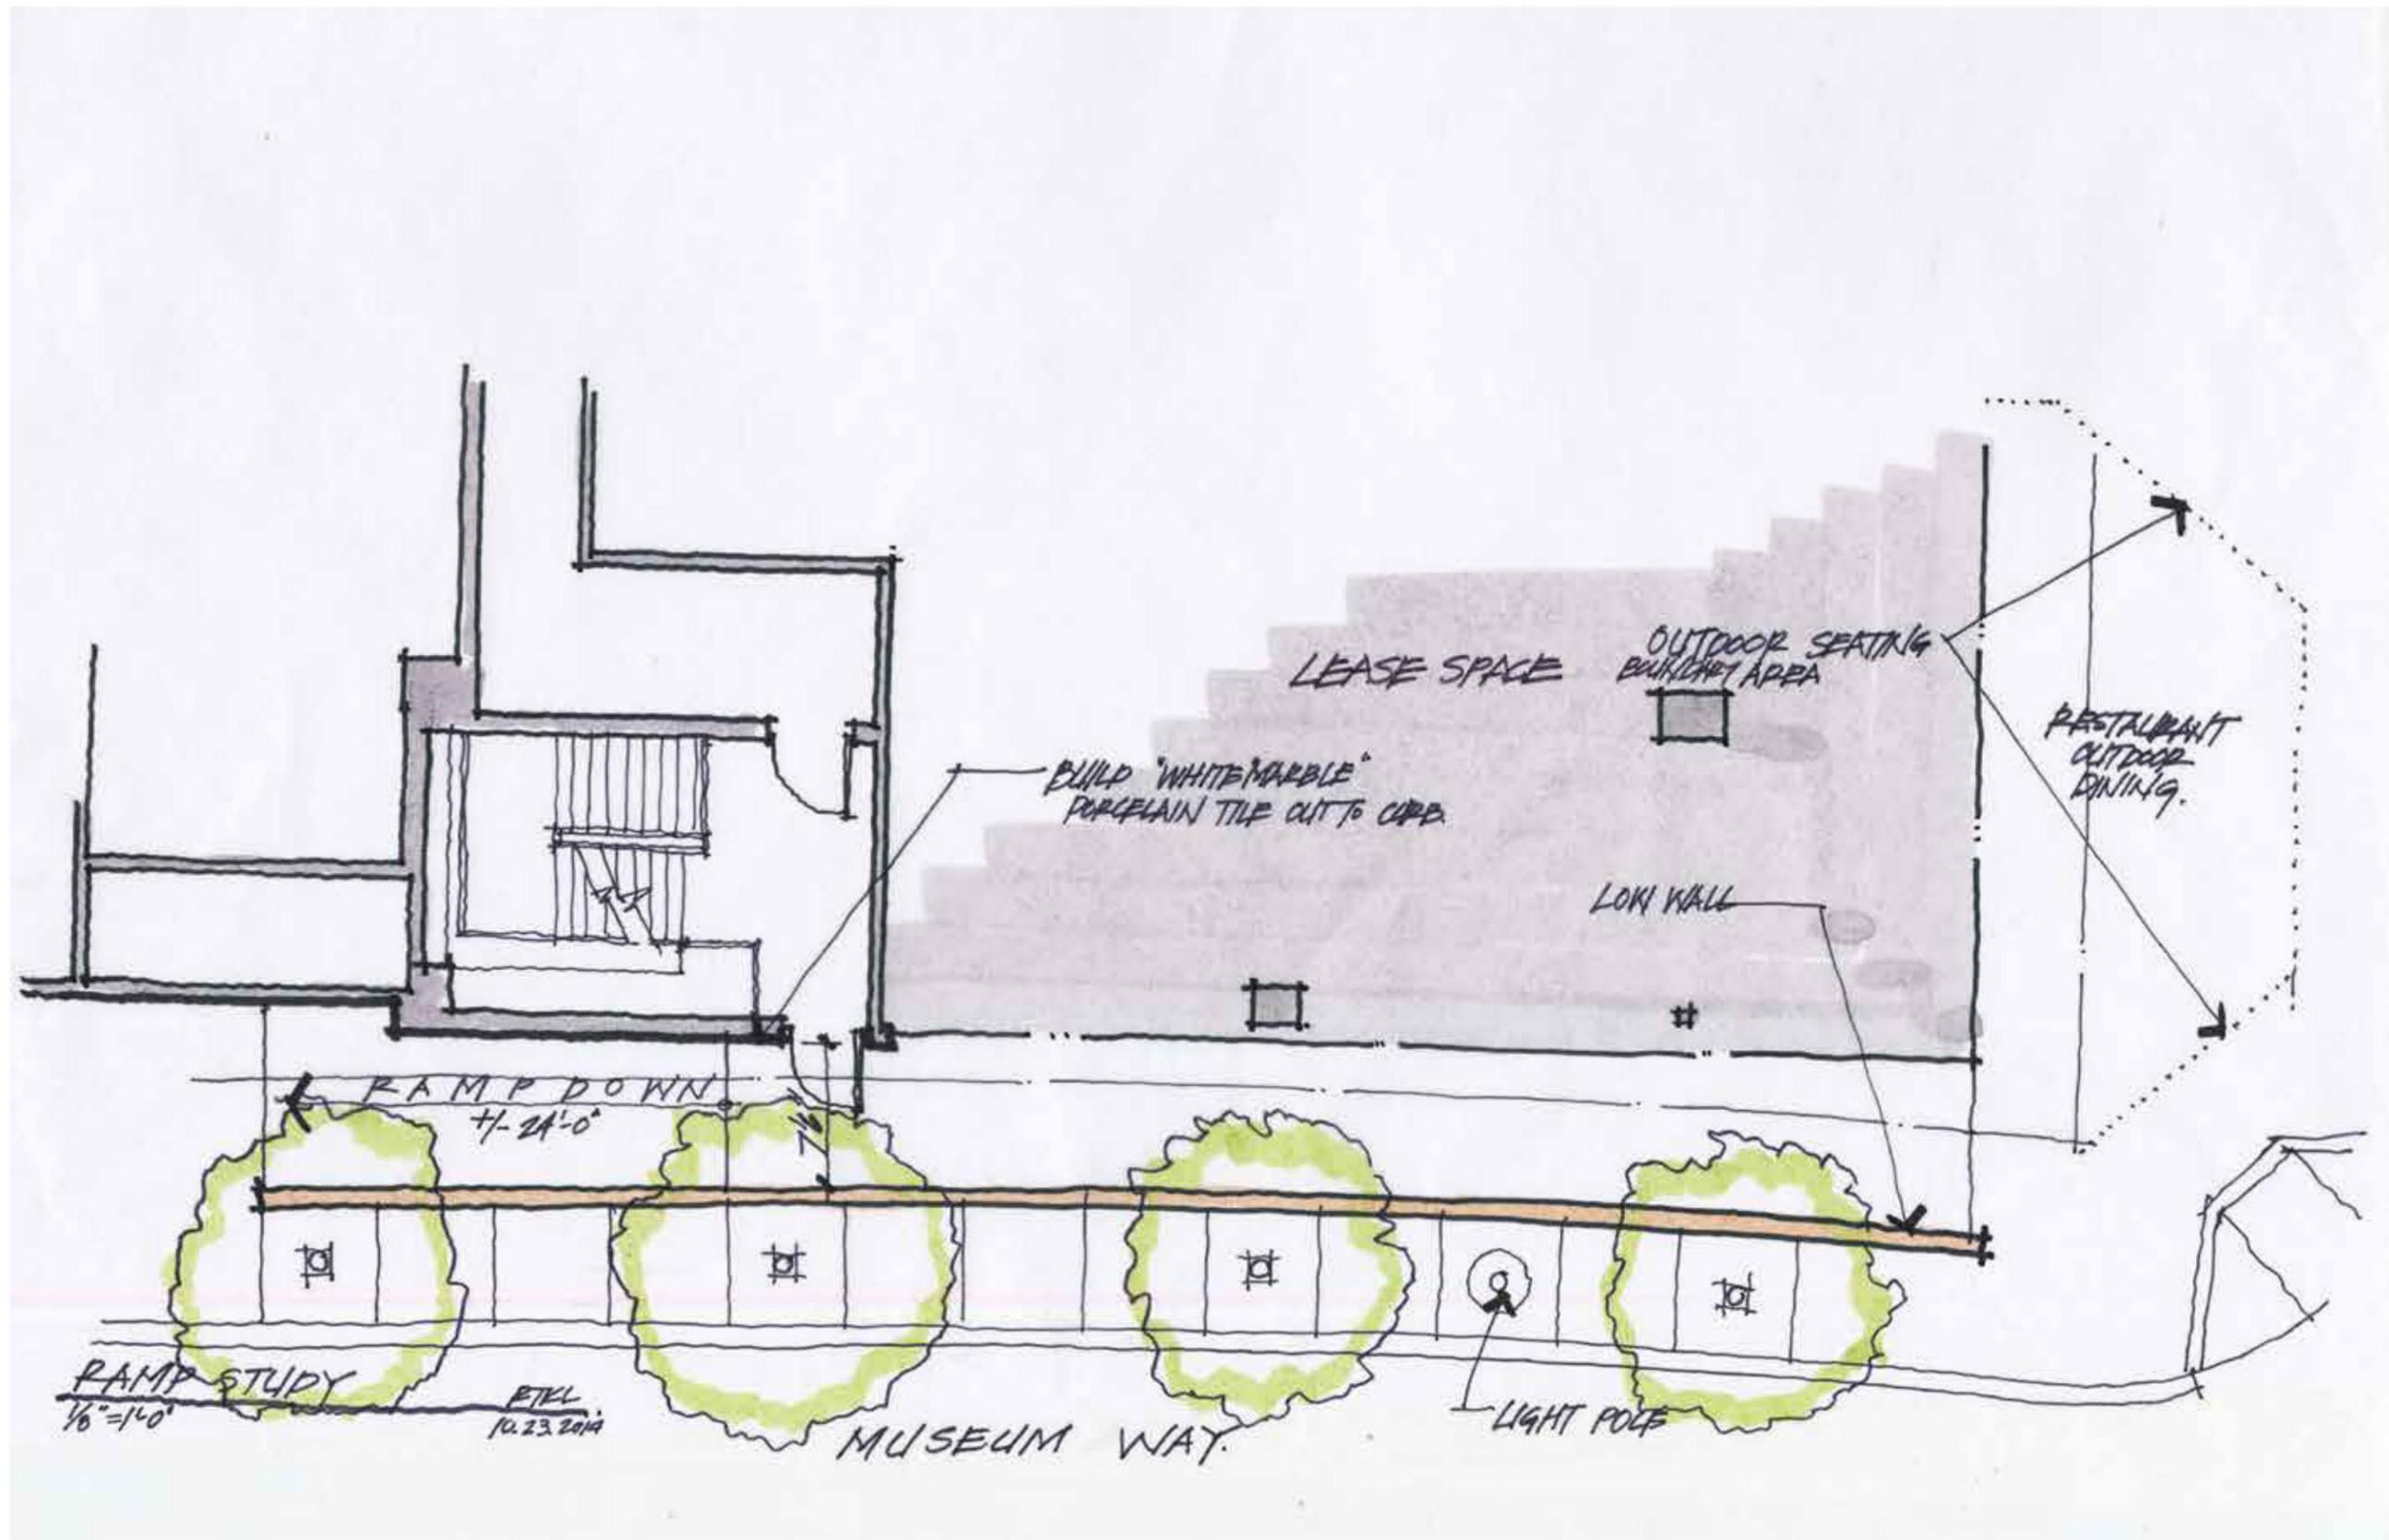
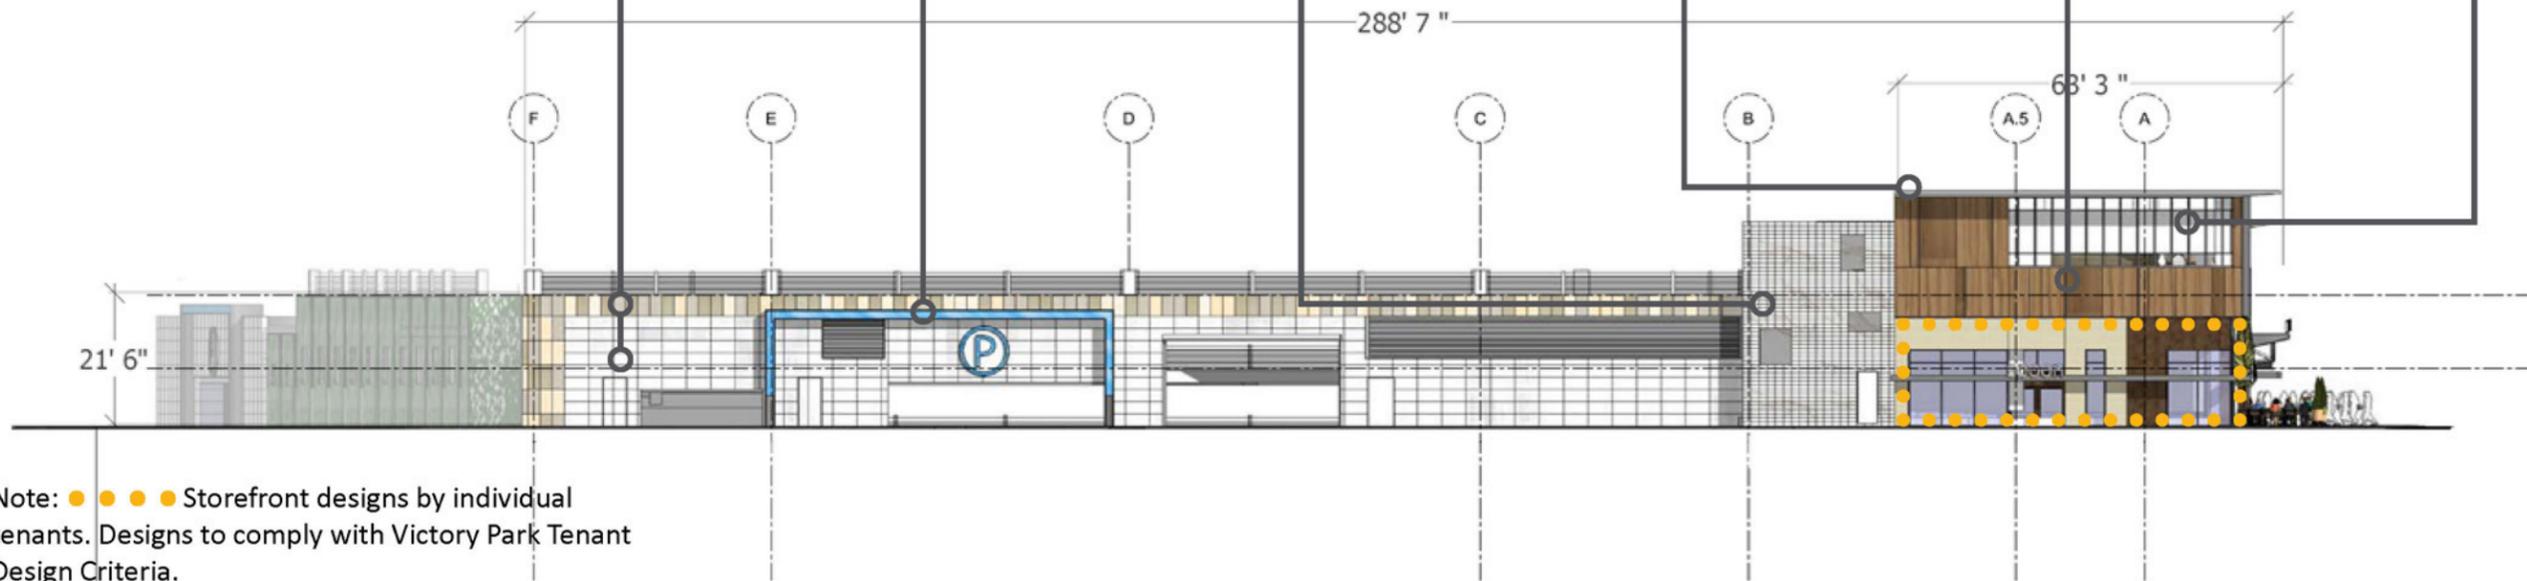
Stucco with high quality finish. 7% coverage of North Elevation. T-207 Pebble Beach, AN-204 White Sand, OC-223 French Roast

Back lit acrylic in metal frame. 5% Coverage of South Elevation

Burnished Block. 18% coverage of South Elevation.

Metal Panel. 1% coverage of South Elevation.

Trespa with wood-like finish. 9% coverage of South Elevation

Facid structural system with Ferrari Fabric. 5% coverage of South Elevation

*Percentage of each material coverage is an approximation and does not include the horizontal area covered by each material.

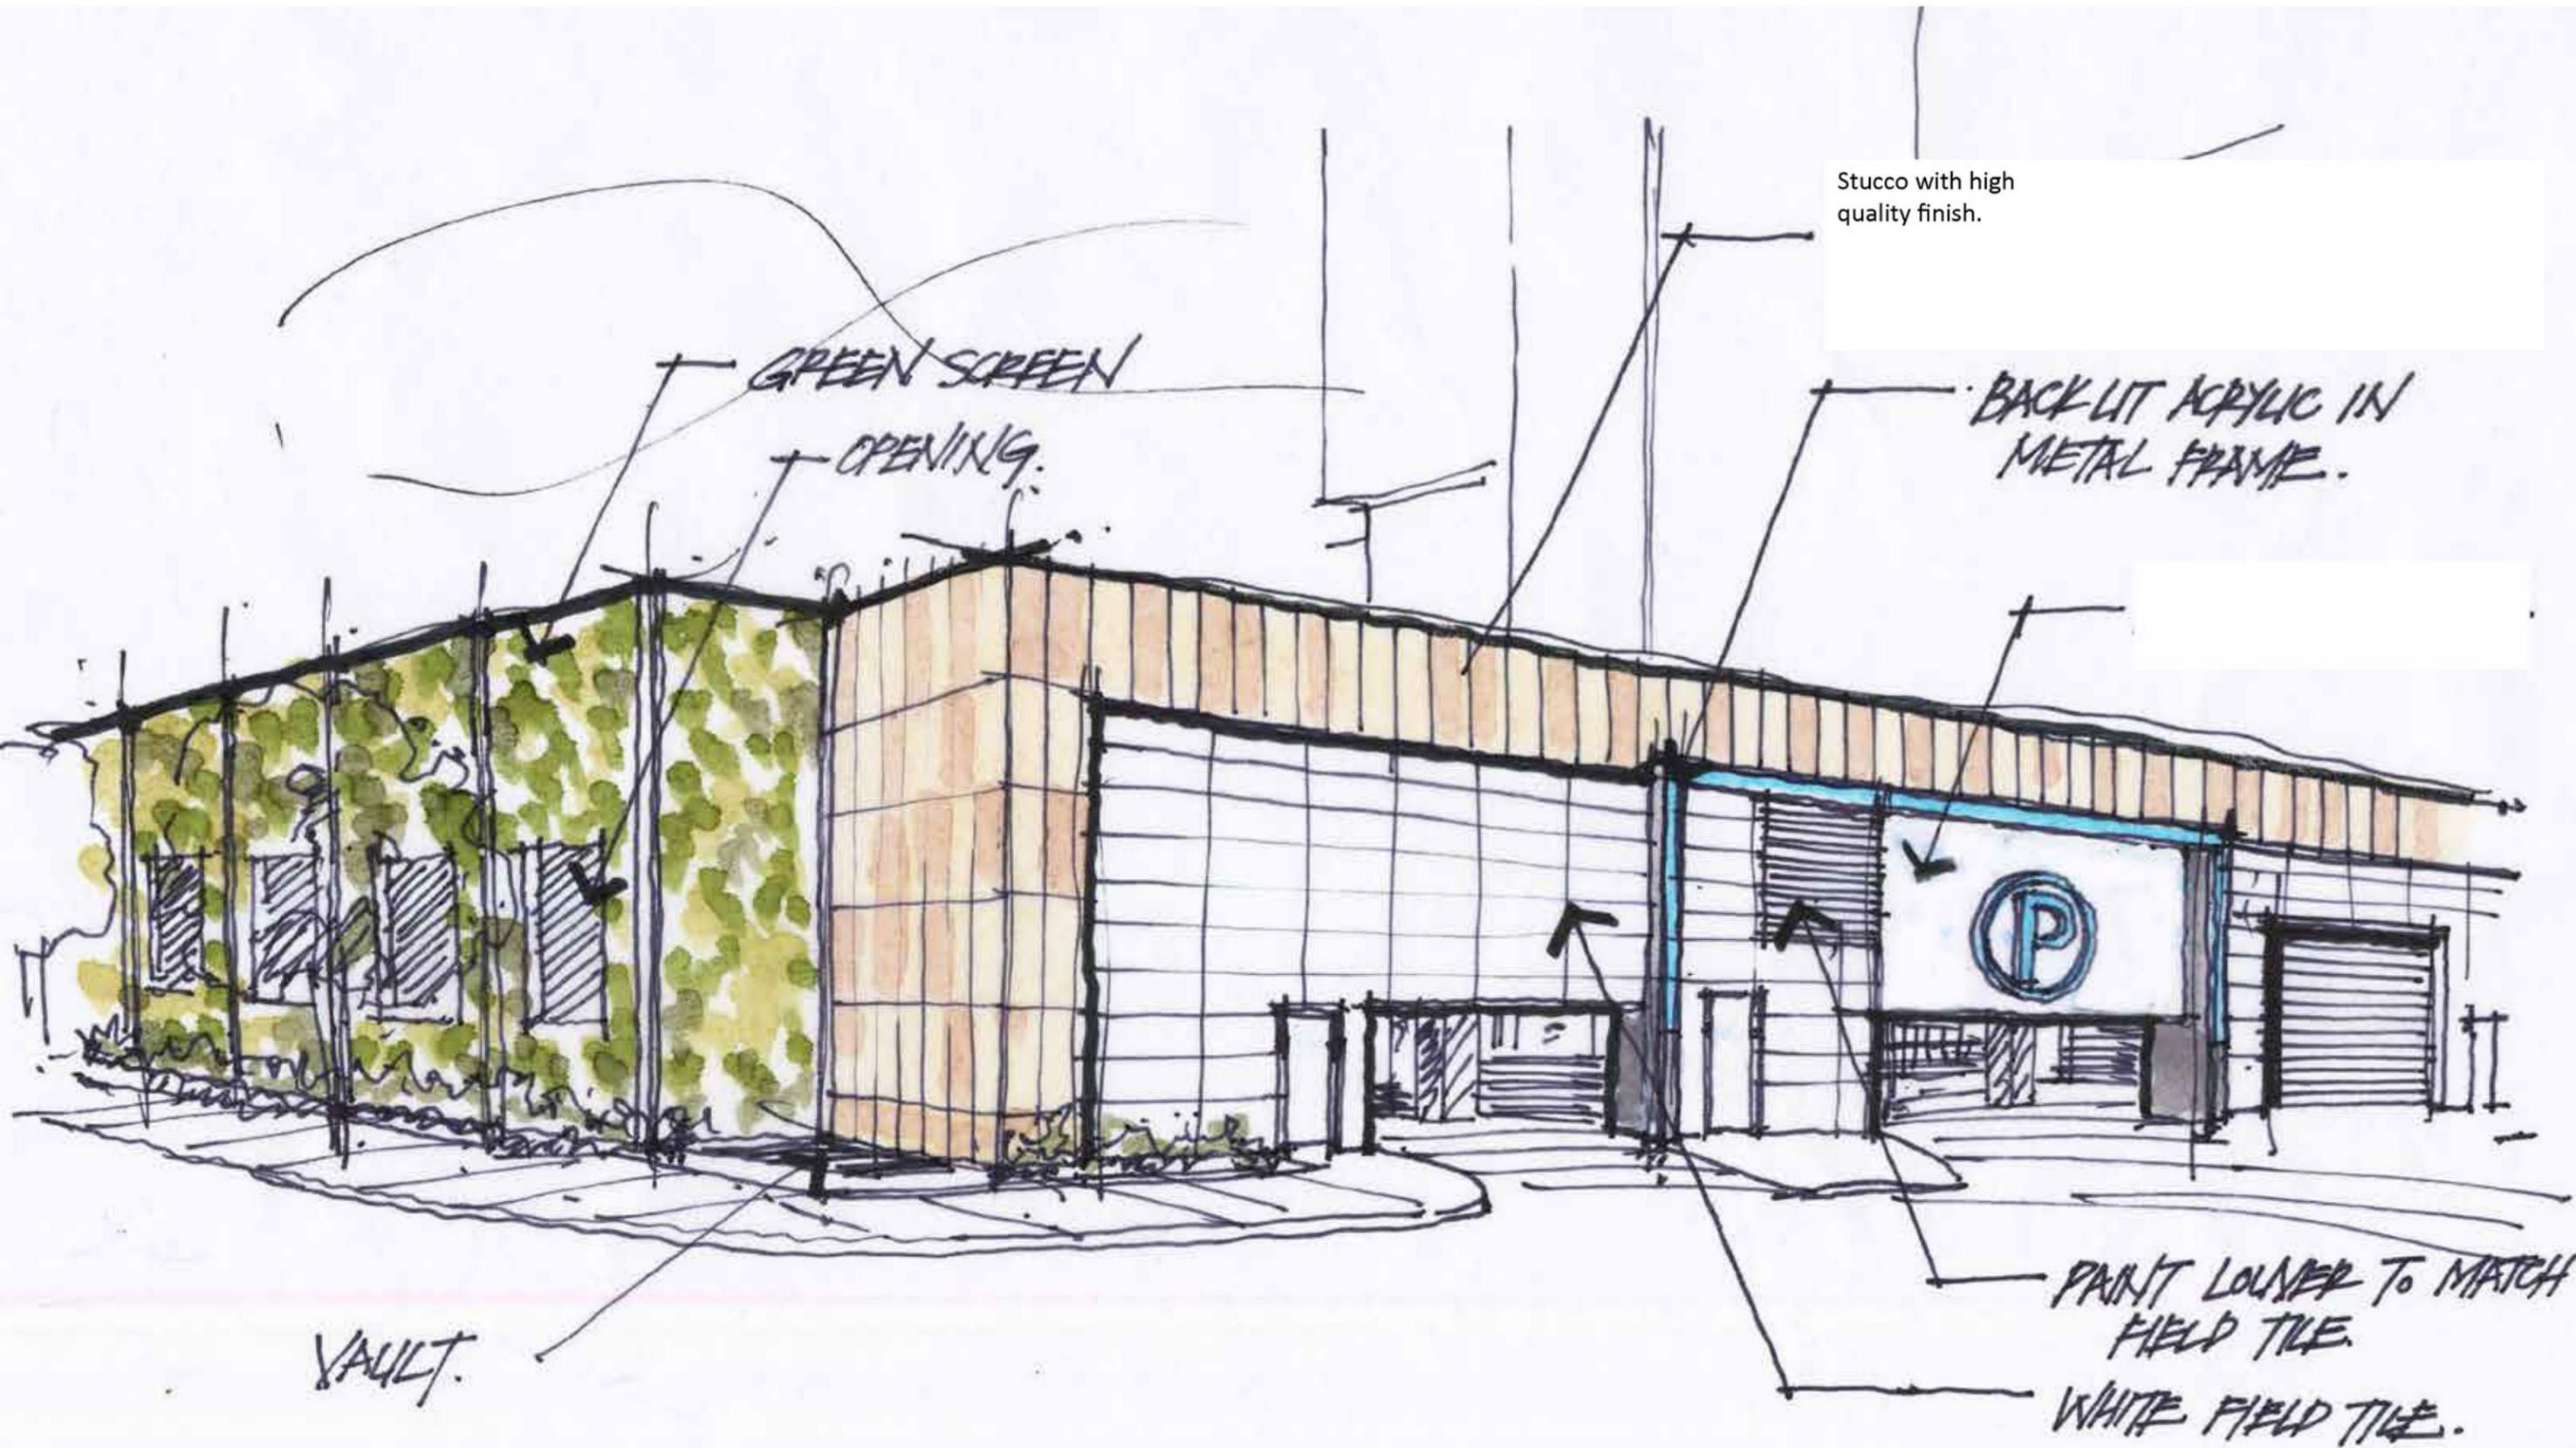
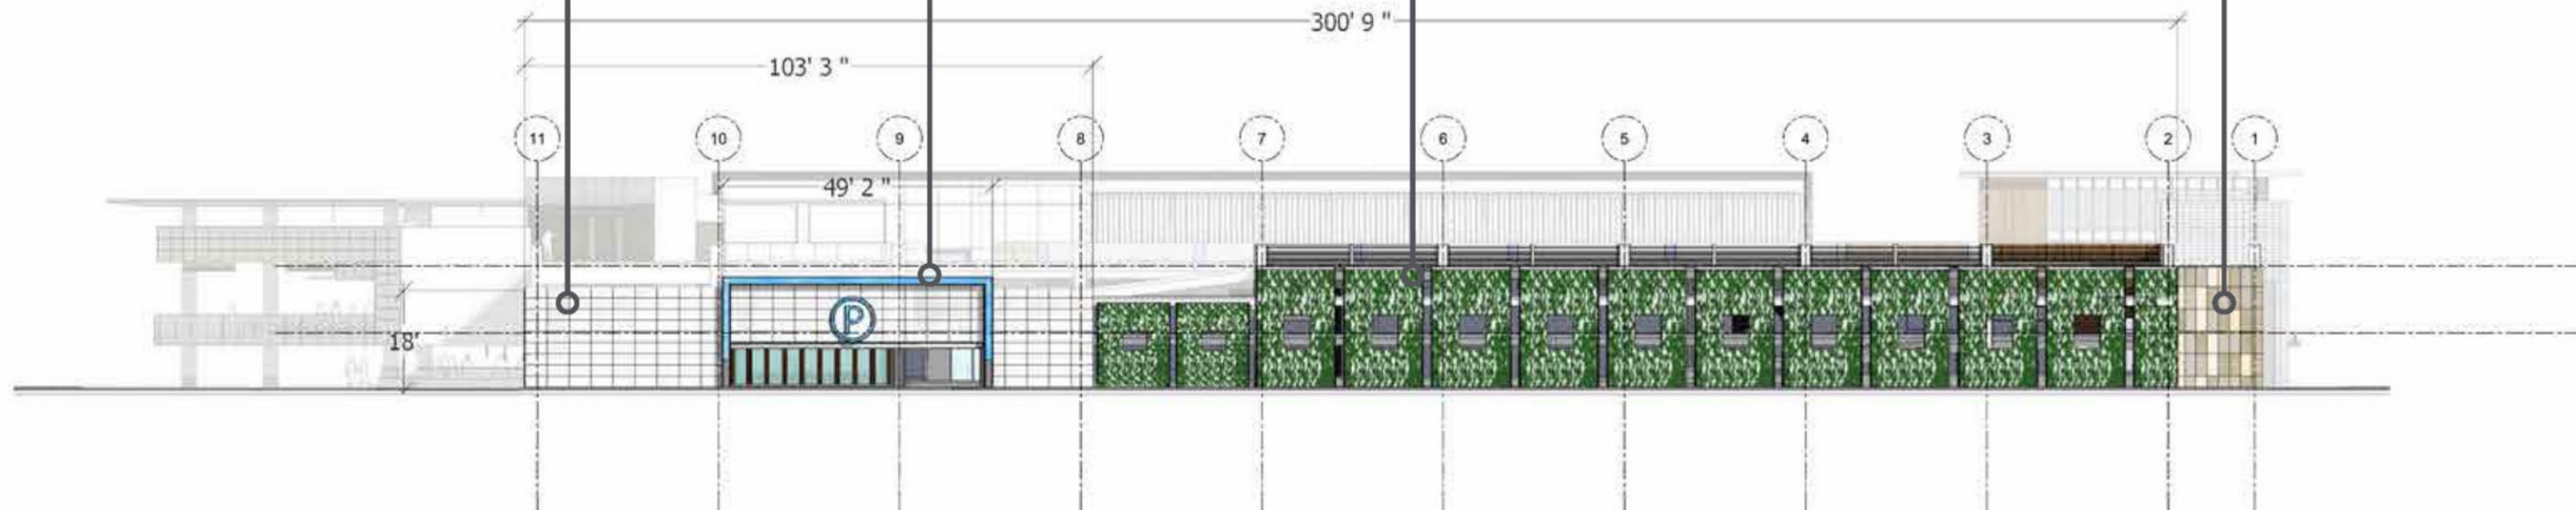
WEST ELEVATION

Stucco with high quality finish.

GREEN SCREEN
OPENING.

BACK-LIT ACRYLIC IN
METAL FRAME.

PAINT LOWER TO MATCH
FIELD TILE.

WHITE FIELD TILE.

VAULT.

Stucco with high quality finish. 28% coverage of West Elevation. AN-204 White

Back lit acrylic in metal frame. 2% Coverage of West Elevation.

Green Screen. 63% Coverage of West Elevation

*Percentage of each material coverage is an approximation and does not include the horizontal area covered by each material.
