The site for the Victory Block D Garage improvements is located west of the W Hotel with primary frontages on Victory Park Lane and Victory Avenue. The site currently exists as a single use garage with three levels of structured parking, two of which are above grade.

Victory Block D Garage

VICTORY PARK

BLOCK D RETAIL & GARAGE IMPROVEMENTS

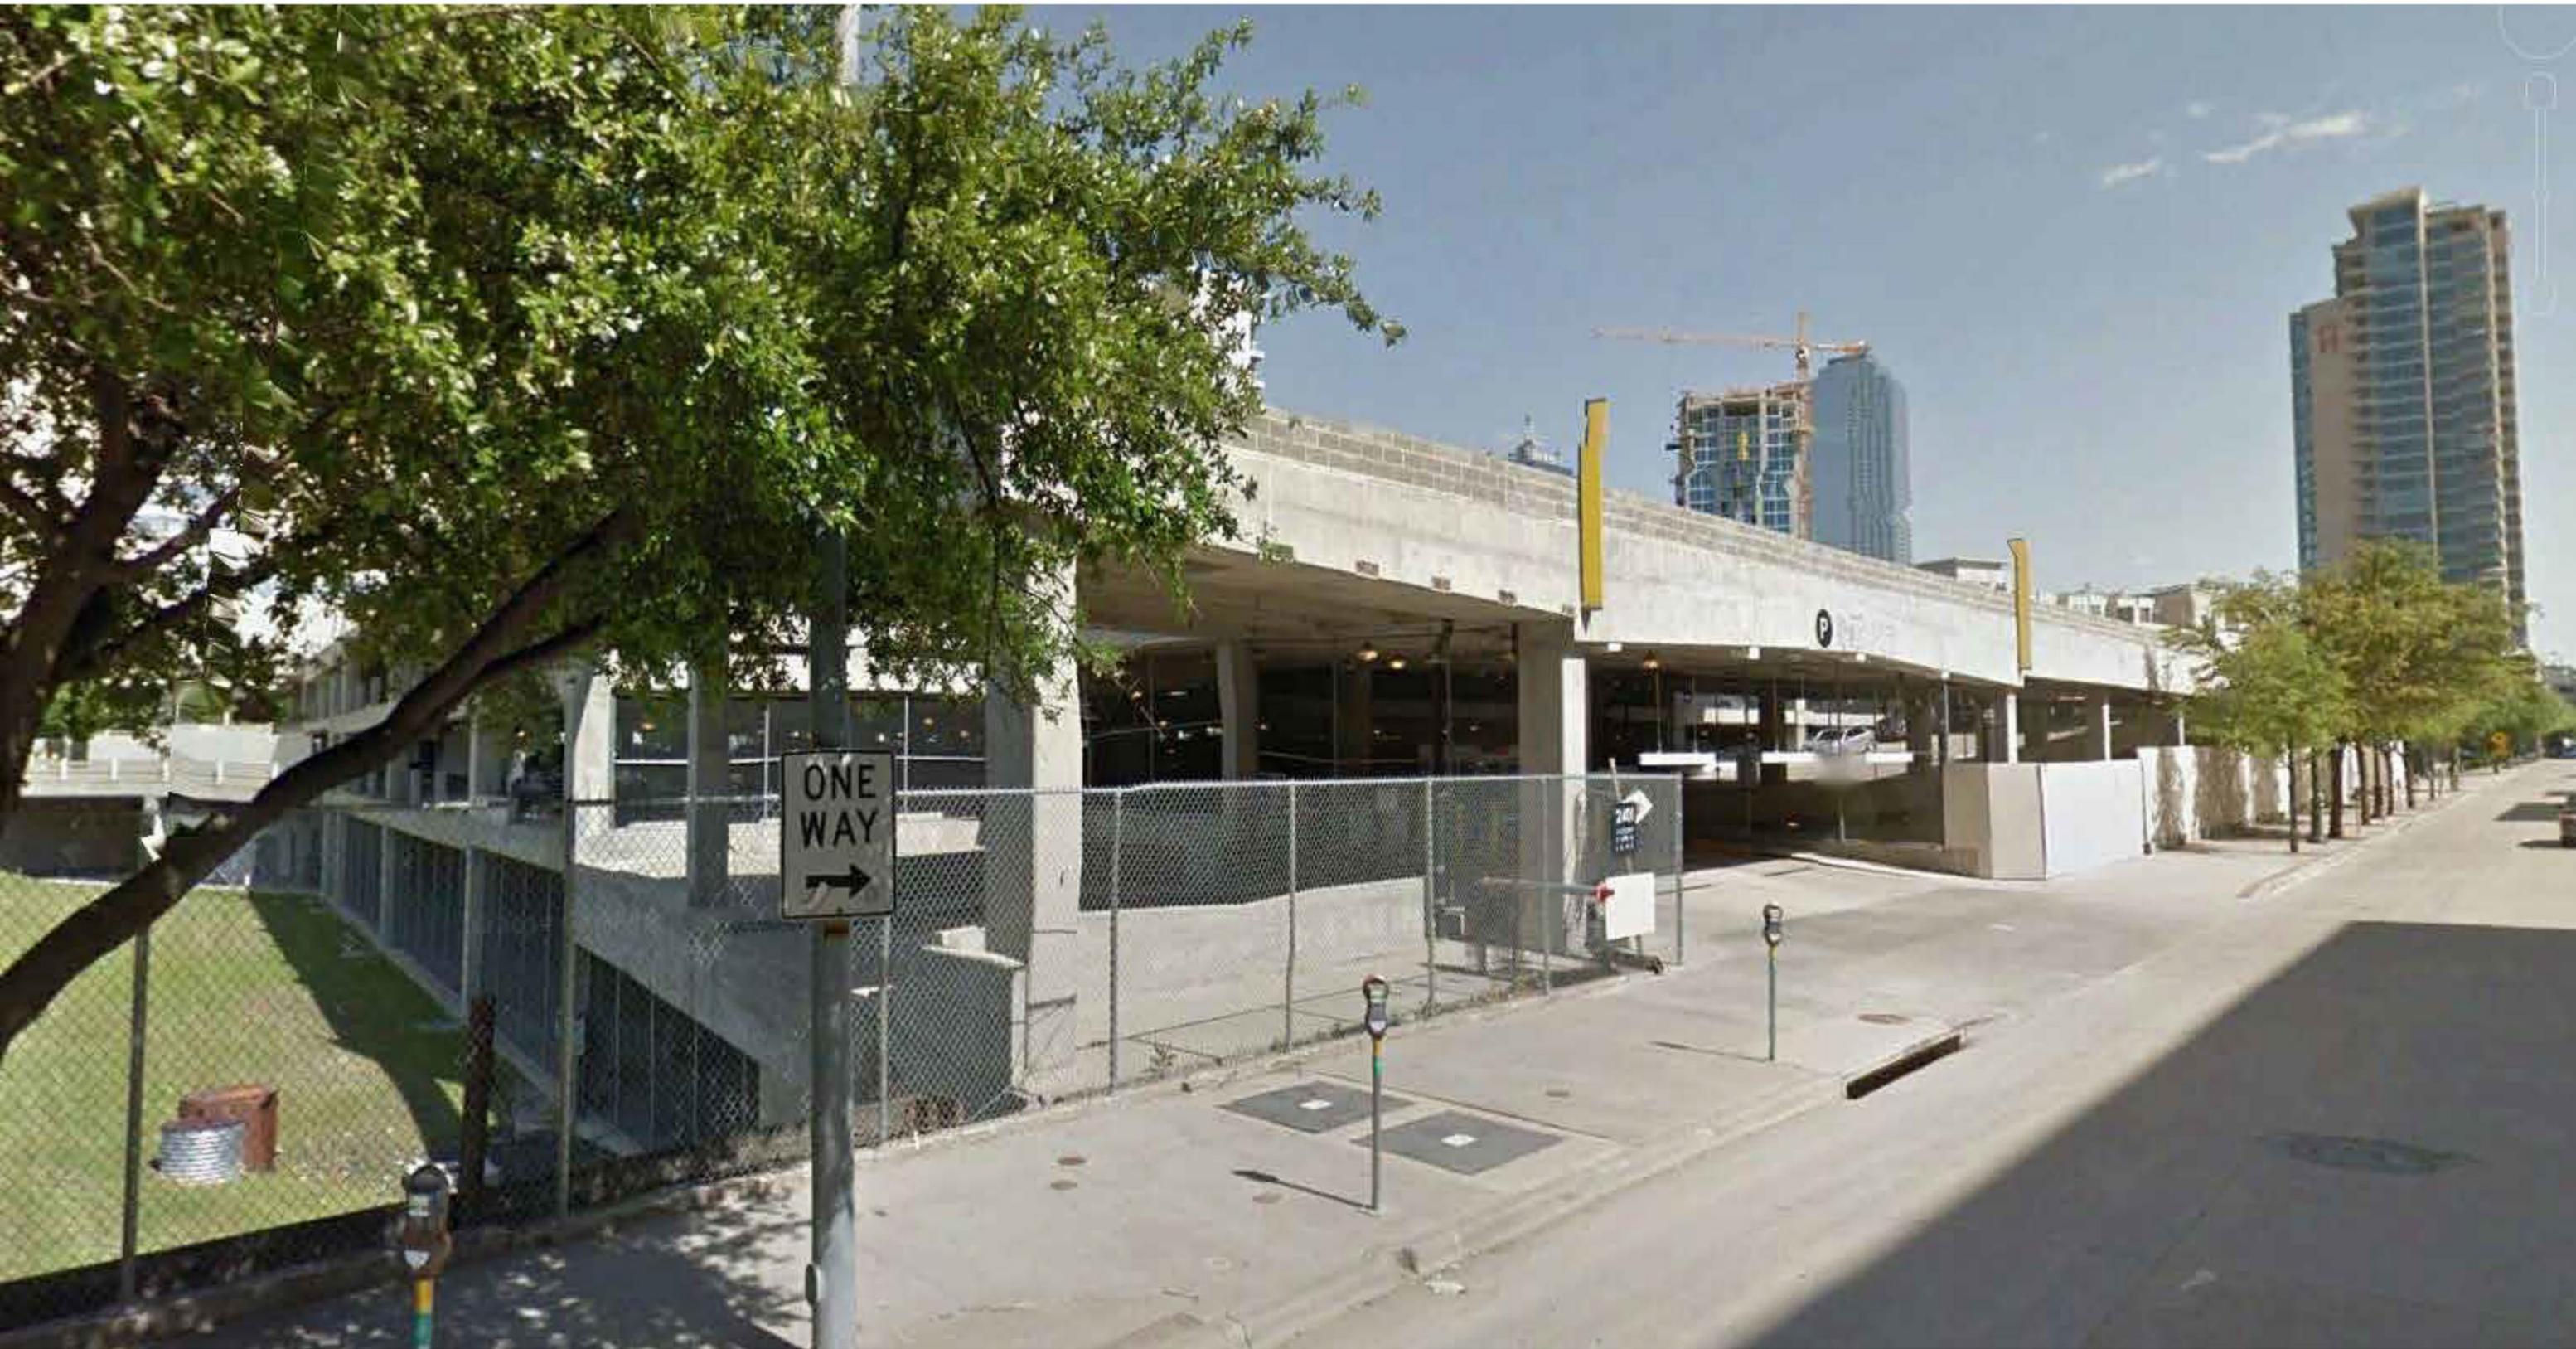
Stucco with high quality finish.

PAINT EXTERIOR STRUCTURE OF GARAGE WHITE.

BACK LIT ACRYLIC IN METAL FRAME

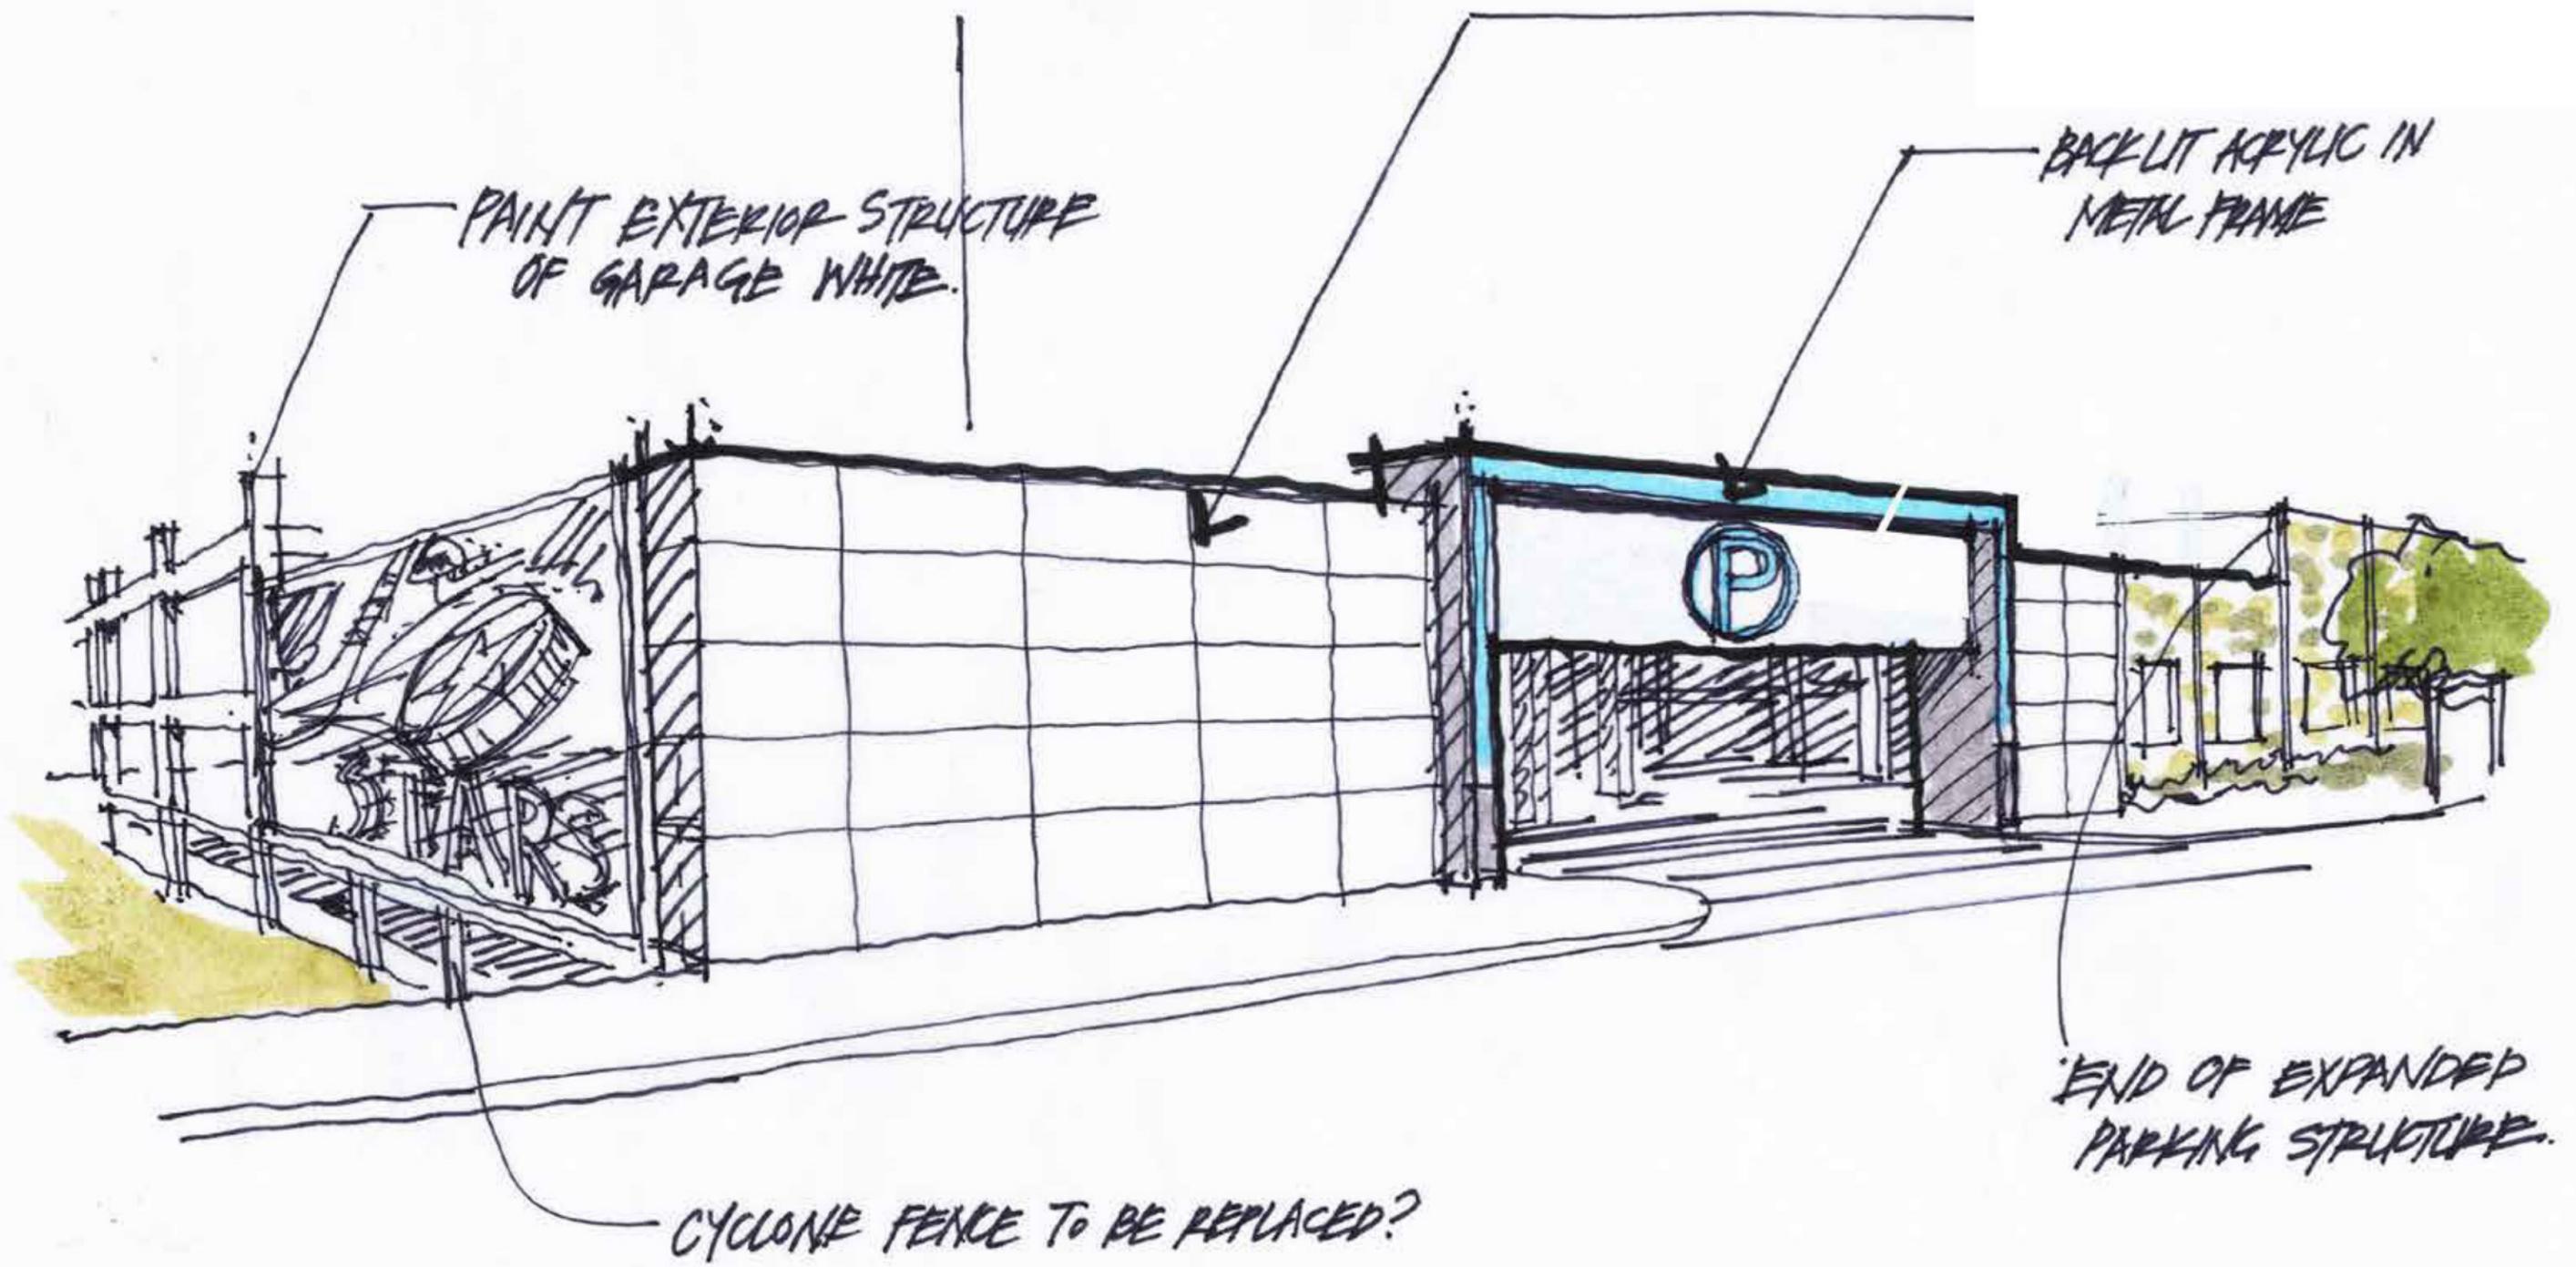
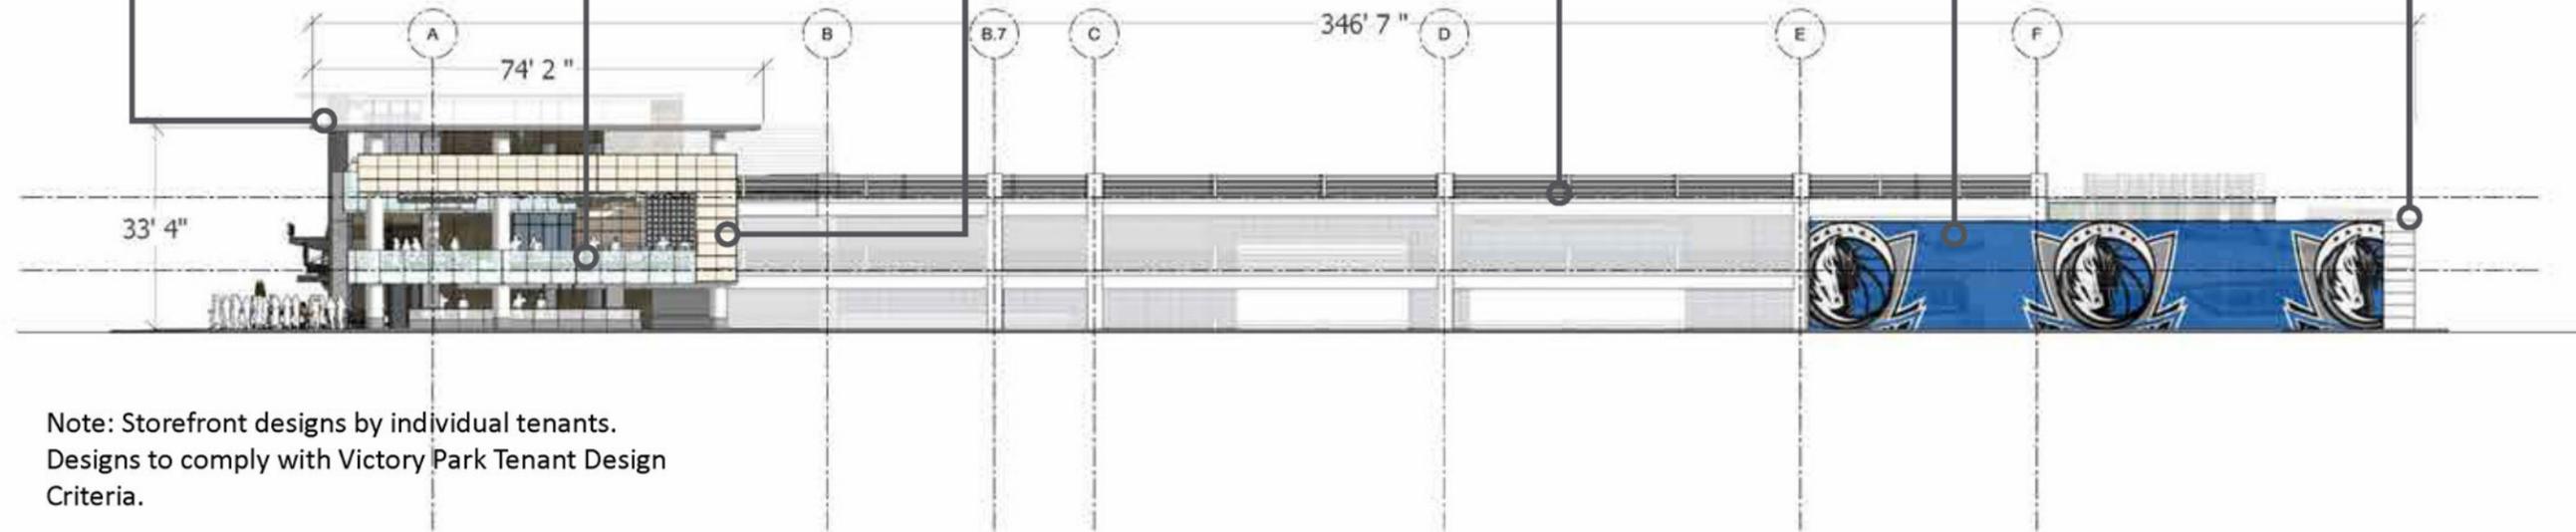
END OF EXPANDED PARKING STRUCTURE.

CYCLONE FENCE TO BE REPLACED?

Metal Panel. 4% coverage of North Elevation.

Point supported guard rail. 38% coverage of North Elevation.

Trespa. 51% coverage of North Elevation.

Paint existing structure.

Potential graphic signage. (Content to be determined)

Stucco with high quality finish. 7% coverage of North Elevation. T-207 Pebble Beach, AN-204 White Sand, OC-223 French Roast

*Percentage of each material coverage is an approximation and does not include the horizontal area covered by each material.
